15 April 2020

Reference: 198 River Street - Updated Conditions Assessment

We visited 198 River Street in New Haven, CT on 2 February 2020 to perform a structural conditions assessment of the five structures remaining on the site. We present our findings from the visit in the following report. For the purposes of this study, River Street is considered to run in the east-west direction, with the buildings facing north.

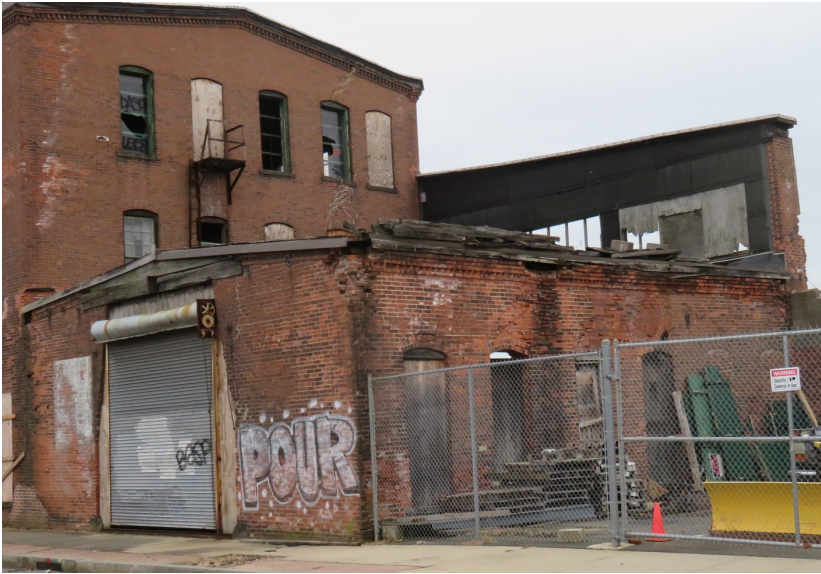
Current Condition: Observations of the condition of the roof framing are in line with those from 2011 (see below). No apparent roof leaks are currently visible; however, the south side is open to the elements. In addition, the masonry at the eaves along the west wall appears to be compromised in a few areas. The cracking in the masonry noted in 2011 appears to have been caused in part by corrosion of steel embedments into the masonry at the truss bearings.

Top: Street-facing view showing taller wall at rear of structure and damaged masonry at east eaves.

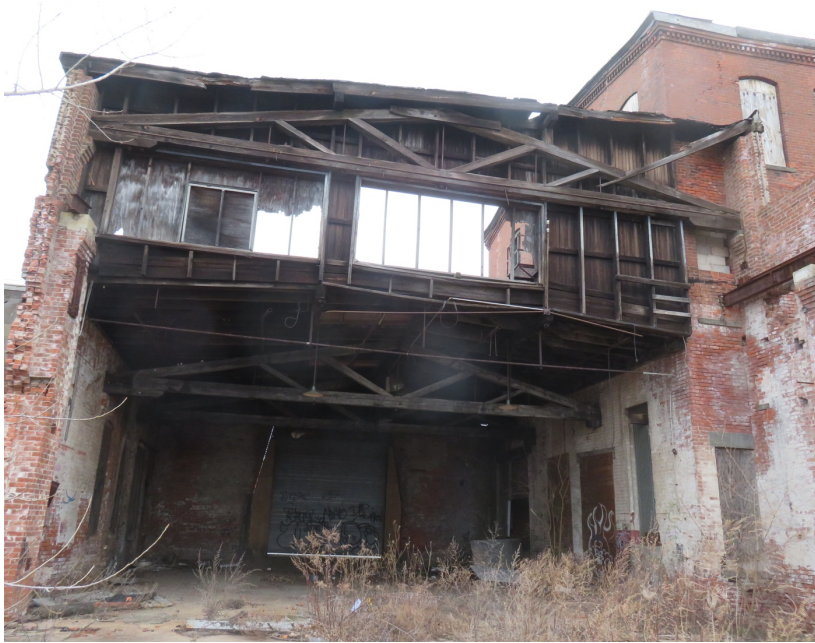
Current Recommendations: Due to the apparent ability of the roof to shed water; the condition of the framing in this building is generally better than the others. The most vulnerable weakness of Building 1 is the absence of a wall on its south side to protect the framing from moisture and damaging wind. It is our opinion that repair for adaptive re-use is possible with appropriate funding. The "core and shell" scope for repair and adaptive re-use would entail the introduction of a building enclosure on the

Middle: Rear-facing view showing higher end-truss in wall of former abutting building.

south wall together with new support for the roof purlins if the high truss “parapet” is to be removed, replacement or sistering of damaged roof framing and decking, inspection and remediation of corroded hardware at truss ends, cutting / pointing masonry, and crack repair of masonry. Installation of a temporary south wall in the short-term would slow the rate of deterioration and protect the roof framing from wind uplift forces.

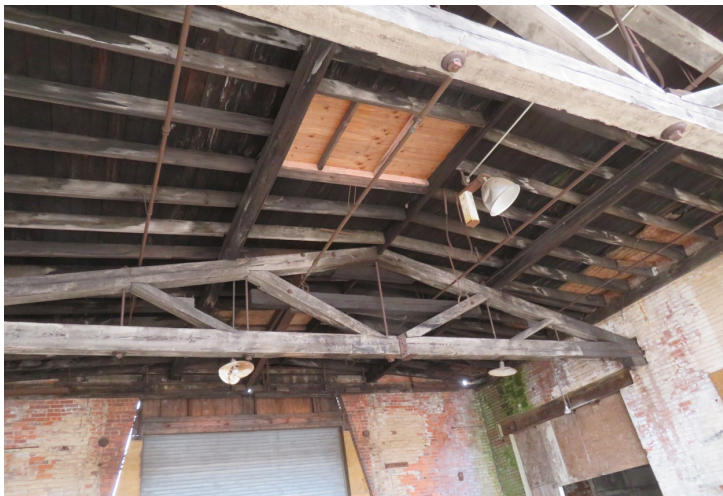
Bottom Left: Interior view showing typical roof framing arrangement.

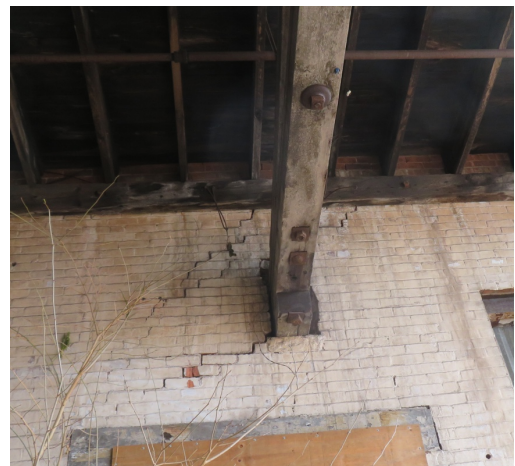
Bottom Right: Cracks in masonry at truss ends due to corroding hardware.

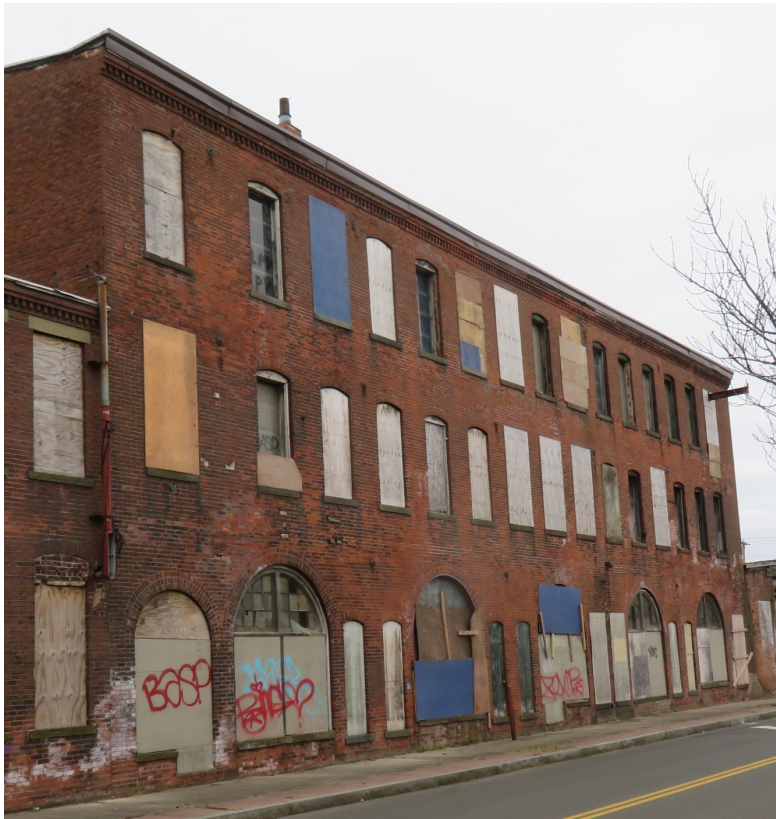
Top: Street-facing view.

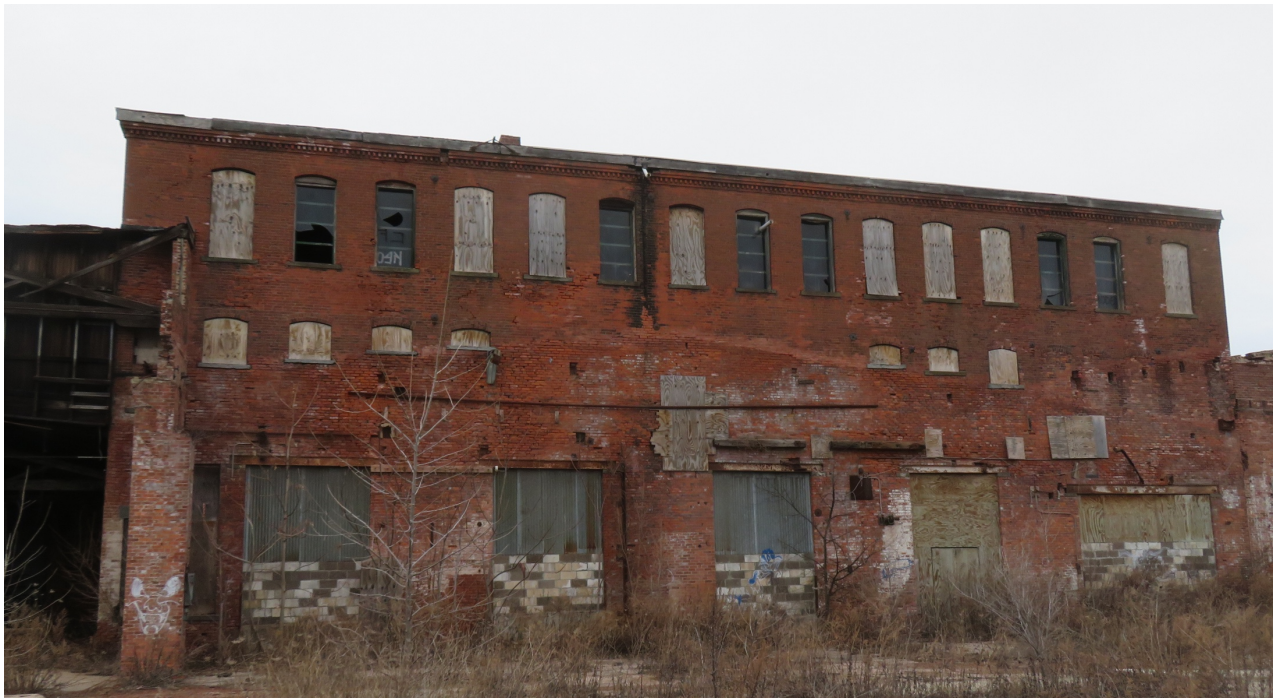
Current Condition: The 2011 recommendation to demolish the building in its entirety was not carried out. Observations of the condition of the floor and roof framing are in line with those from 2011 (see below). The roof was observed from the ladder truck, and some areas of the roofing are completely breached and appear to correspond with leaking and deterioration of framing below. An estimated 25% of the floor and roof framing is compromised. The street and rear facing brick masonry appears to be in sound condition except for below the eaves and at the rear where weathering has occurred at former interior portions that became exposed to the elements when the rear structures were removed. In these locations, the softer brick, not intended to sustain environmental exposure have become weathered.

Bottom: Rear-facing view showing outline of former building with the previously interior protected brick now exposed.

Current Recommendations: While certain areas of the framing have been compromised, the intact majority is providing stability for the building as a whole. It is our opinion that repair for adaptive re-use is possible with appropriate funding. The "core and shell" repair scope would entail replacement or sistering of damaged framing and decking, replacement of damaged rafters, sheathing and roofing, cutting / pointing masonry, and crack repair of masonry. Because the roof is currently allowing water into the building and causing ongoing progression of framing deterioration, short-term measures to stop water infiltration would slow the rate of deterioration while a longer-term plan is put into place. Newly exposed portions of the brick on the rear wall that have weathered will require heavy pointing and some local rebuilding.

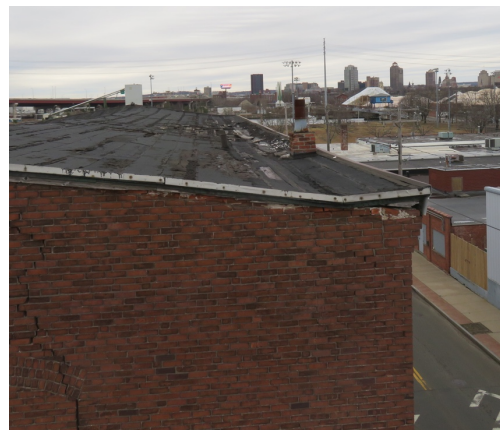
Middle Left: Roof breach along north eave.

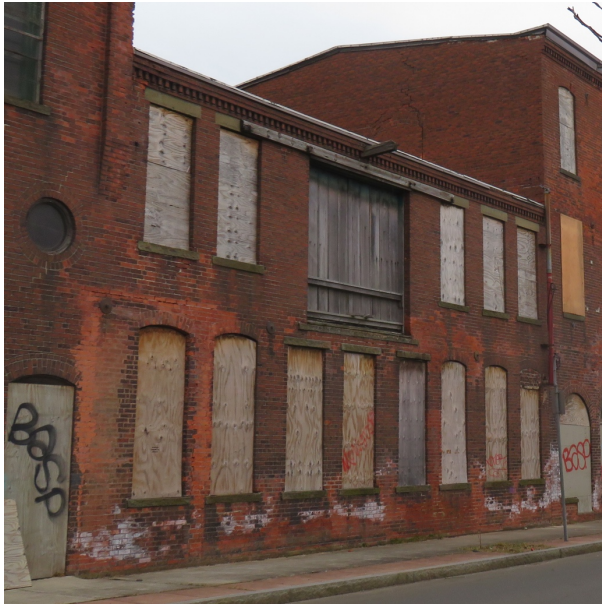
Top Left: Street-facing view.

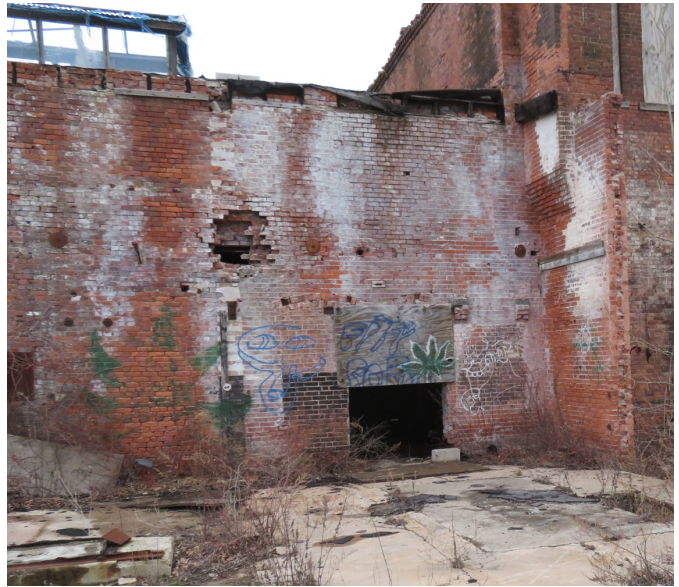
Current Condition: The 2011 recommendation to demolish the building in its entirety was not carried out. Observations of the condition of the floor and roof framing are in line with those from 2011 (see below). The roof was observed from the ladder truck. In addition to the open skylight observed in 2011, an open roof hatch and breaches in roofing are also contributing to water infiltration. **An estimated 40% of the floor and roof framing is compromised.** The street facing brick masonry appears to be in sound condition. The brick on the rear, formerly an interior wall, has experienced water infiltration at the top of the wall which has caused some debonding of the brick wythes.

Top Right: Rear-facing view showing compromised brick.

Current Recommendations: While certain areas of the framing have been compromised, the intact majority is providing stability for the building as a whole. It is our opinion that repair for adaptive re-use is possible with appropriate funding. The "core and shell" repair scope would entail replacement or sistering of damaged framing and decking, replacement of damaged rafters, sheathing and roofing, cutting / pointing masonry, and retrofit wall ties and local rebuilding of the rear wall. Because the roof is currently allowing water into the building and causing ongoing progression of framing deterioration, **short-term measures to stop water infiltration would slow the rate of deterioration while a longer-term plan is put into place.**

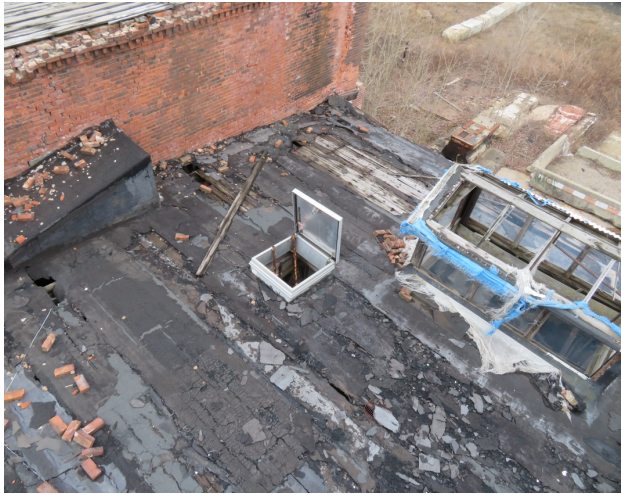
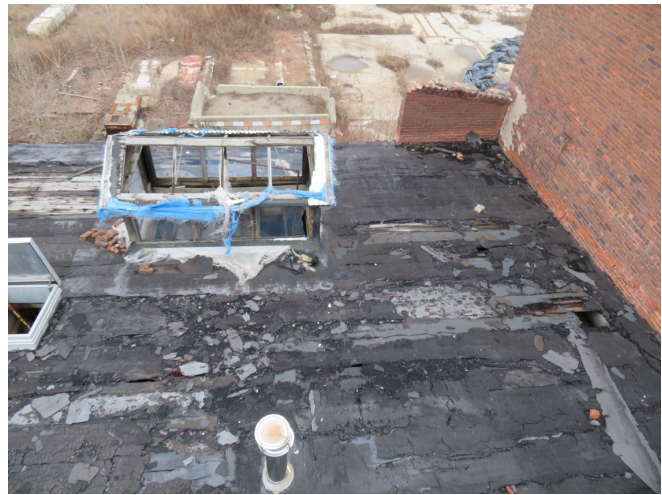
Middle: Roof view showing openings and breaches.

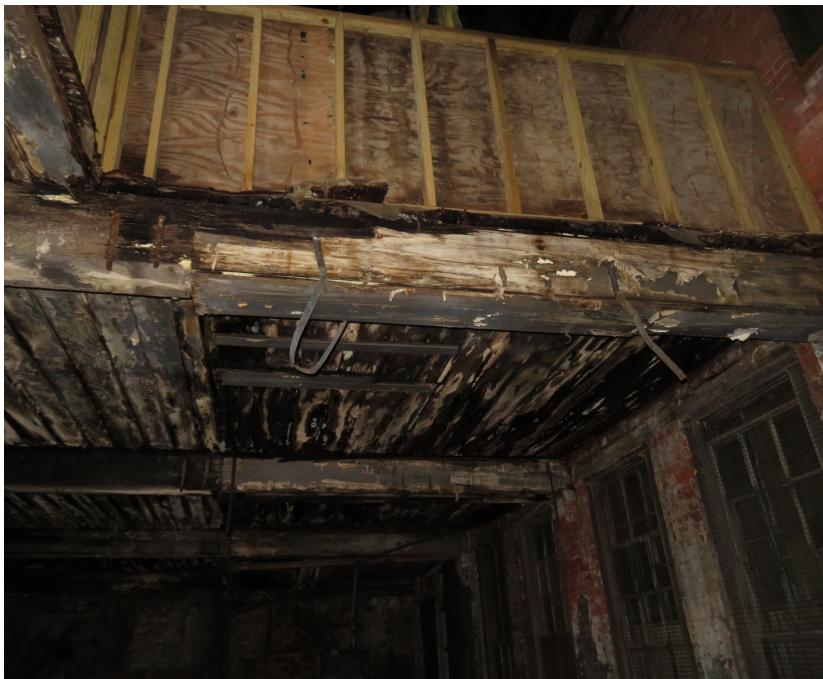
Bottom: Interior view showing framing and deterioration.

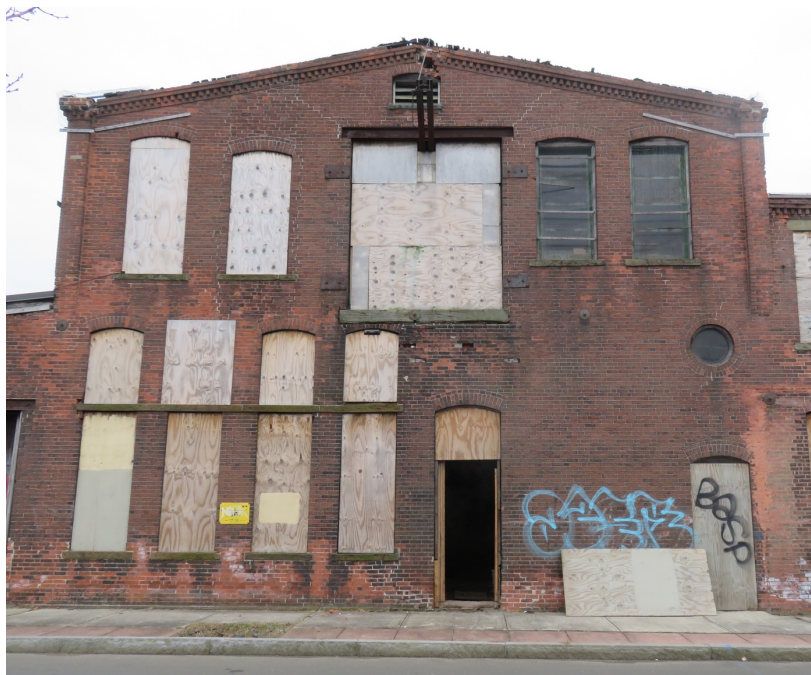
Building 4 Photos:
Top: Street-facing view.

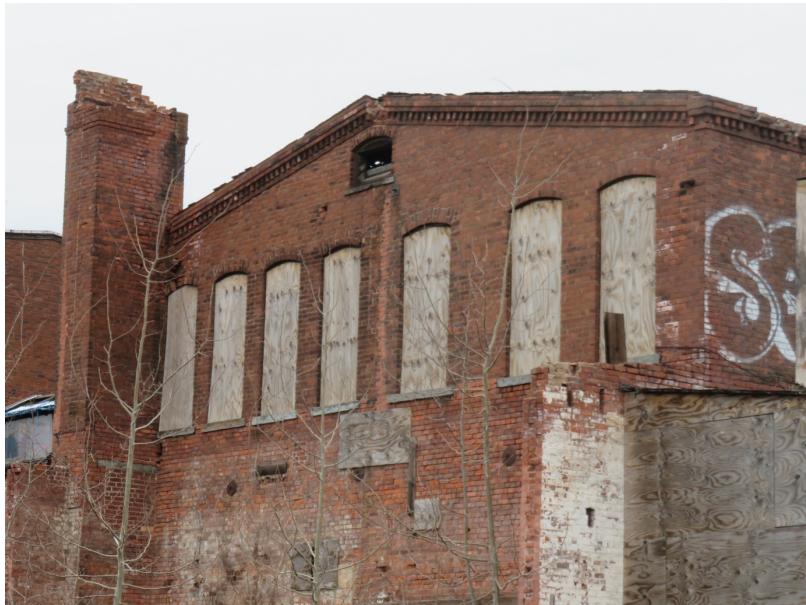
Current Condition: The 2011 recommendation to demolish the building in its entirety was not carried out; however, a post-2011 stabilization campaign included removal of 2nd floor and attic decking and common joists while retaining primary structural beam and column members. Observations of the condition of the roof framing are in line with those from 2011 (see below). The roof was observed from the ladder truck. Most areas of the roofing are completely breached, and roof framing at rafter tails appears unstable in places. Brick masonry at the eaves of the roof is also severely compromised. The condition of the brick masonry below the eave areas and on the gable walls (north and south) is generally sound. The top of the chimney on the rear elevation is in poor shape and crumbling.

*Middle: Rear-facing view
showing crumbling masonry
chimney.*

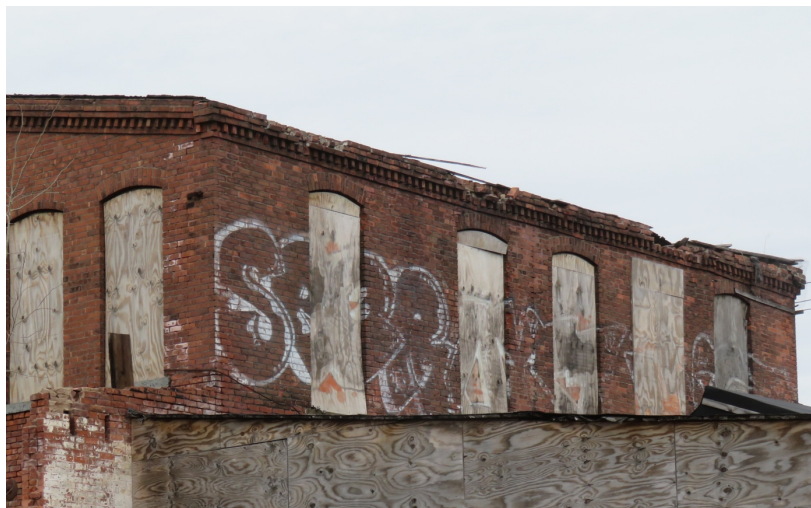
*Bottom: East eave showing
masonry deterioration.*

Current Recommendations: Building 4 is in the worst shape of all of the buildings, and the roof framing is at risk of collapse if not stabilized soon. Without roof framing to brace the upper portions of the exterior masonry walls, these are also at risk of instability following a potential roof collapse. It is our opinion that repair for adaptive re-use is possible with appropriate funding due to the generally stable condition of most of the exterior walls; however, “core and shell” repairs would be extensive and would include re-framing for most of the building including the roof, rebuilding the portion of brick masonry below the eaves and cutting / pointing the rest of the masonry. Because of the severe condition of the roof framing, re-framing and re-roofing must be prioritized in order to keep the building stable. Because the eave masonry supporting the roof framing is compromised in areas, additional eave support would have to be addressed, perhaps by introducing a timber top plate that could be supported from below or by locally rebuilding the brick.

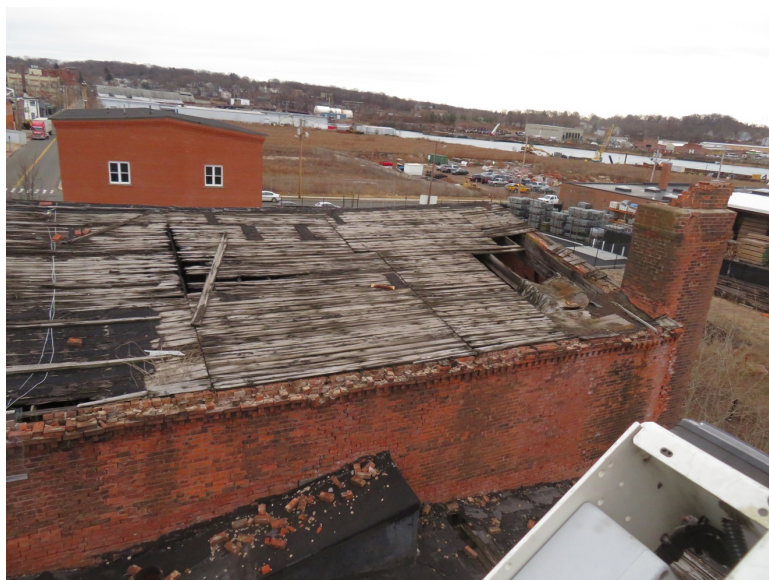
Top: Roof view showing breaches and condition of masonry at eaves.

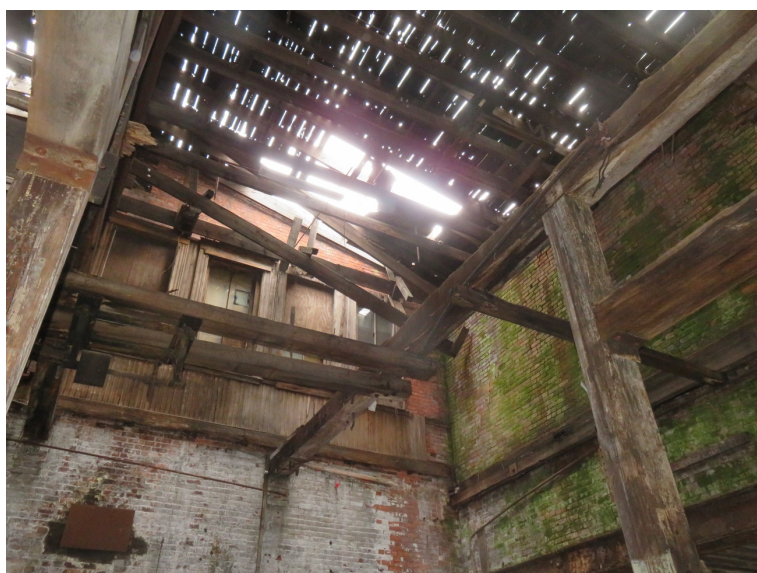
Middle: Interior view showing removal of 2nd floor framing and daylight through roof.

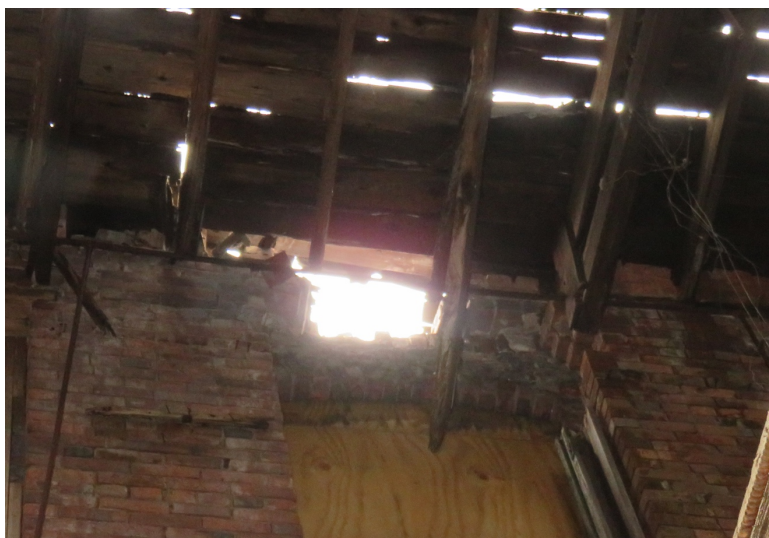
Bottom: Interior view of deteriorated masonry at eave and dropped rafter tails.

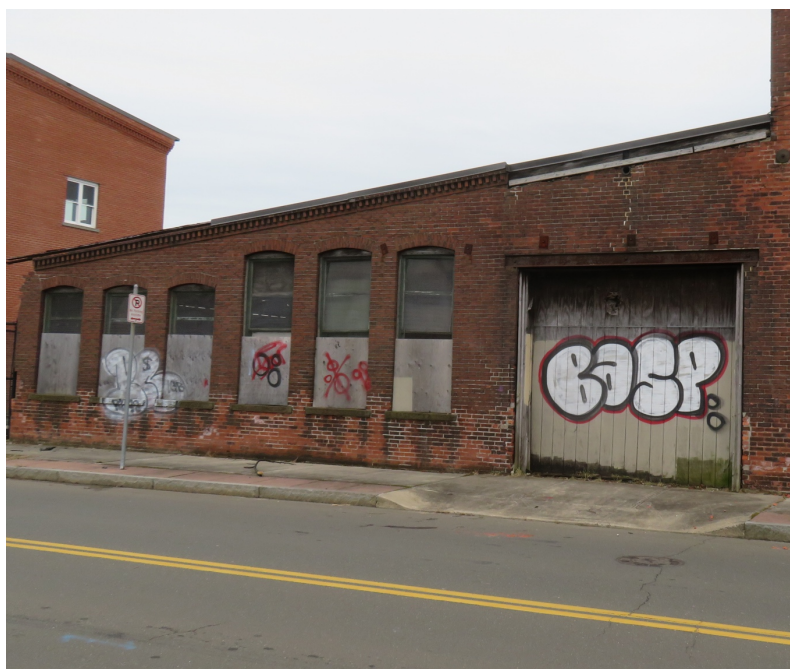
Top: Street-facing view.

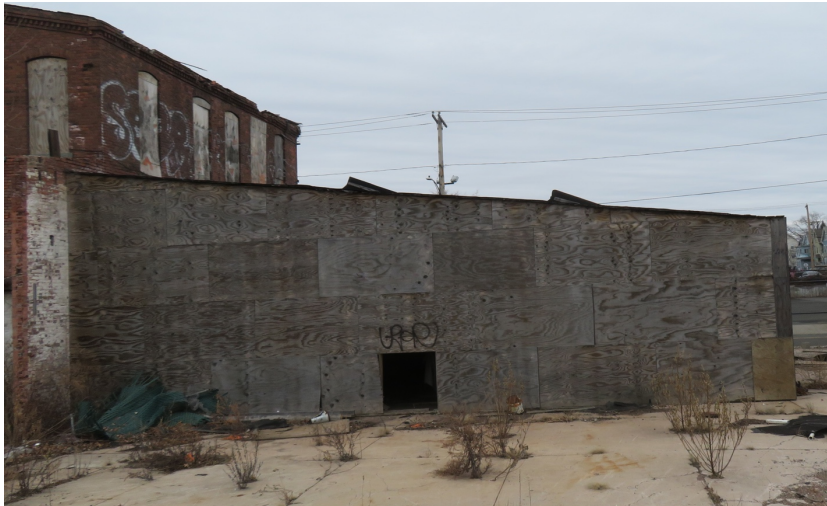
Current Condition: The 2011 recommendation to demolish the building in its entirety was partially carried out; however, the north-facing street-fronting portion of Building 5 was retained, and a temporary wall was constructed on the south and east sides (where the Building 6 wall which supported the Building 5 rafters was removed). The removal of the south side of the building appears to have remediated all roof leaking observed in 2011 with the exception of water infiltrating the temporary south and east walls at the eaves. Other than the need to provide more permanent walls at the south and east sides, Building 5 is in relatively sound condition.

Top: Rear view showing temporary south wall.

Current Recommendations: It is our opinion that repair for adaptive re-use is possible with appropriate funding. The "core and shell" repair scope would entail the introduction of a building enclosure on the south and east walls together with repairs to the east girder and posts if found to be damaged and cutting / pointing masonry on the front elevation.

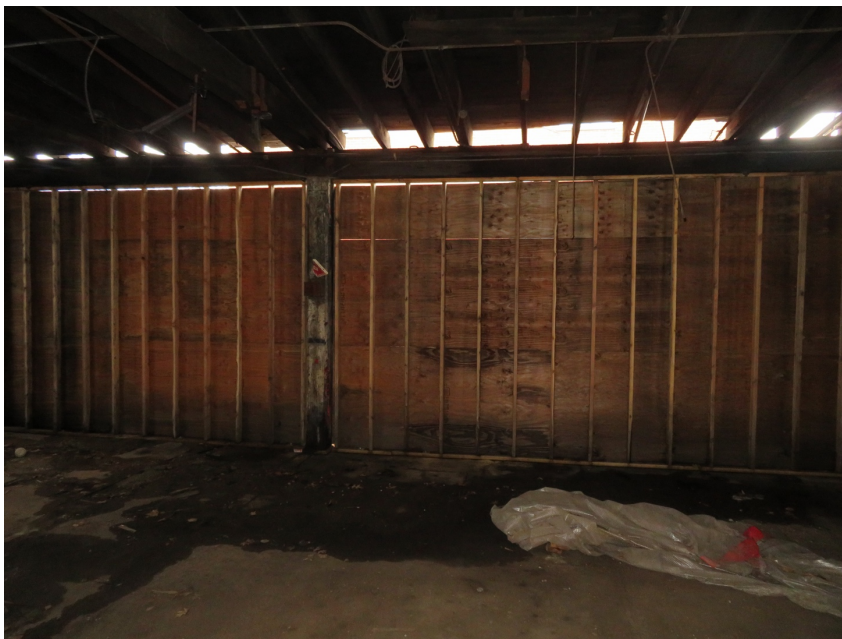
Bottom: Interior view of temporary east wall showing daylight between the rafters and water on the floor after a storm.
