Strong School Building

Facility Assessment – October 2012

69 Grand Avenue – New Haven - Connecticut

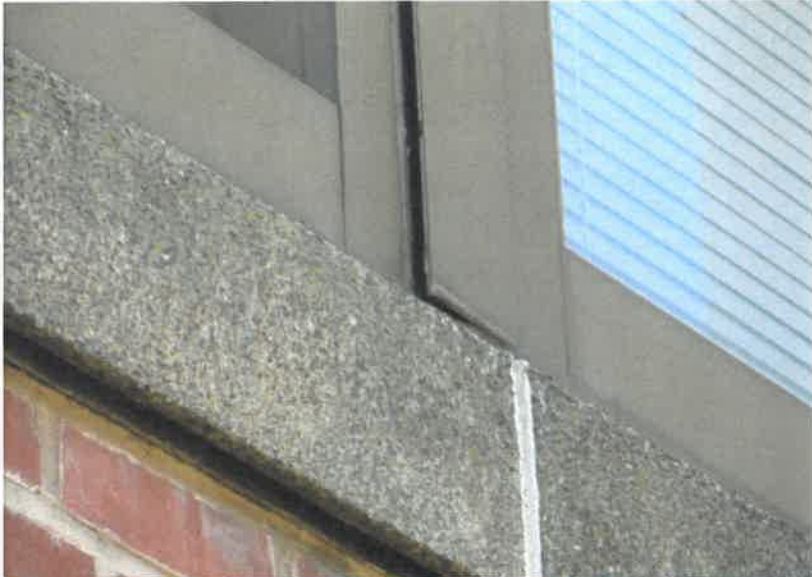
Photo # 9

Exterior windows consist of tinted insulated glazing in aluminum frames. Glazing assemblies are in good condition. Exterior sealant in some of the transition assemblies has begun to fail and may allow water and air infiltration (see photo 9).

South side windows - transition assemblies have begun to fail and may allow water and air infiltration.

1. Fire and security alarm systems should be tested and repaired as needed
2. Redo exterior sealant at all doors and windows to help determine source of leaks

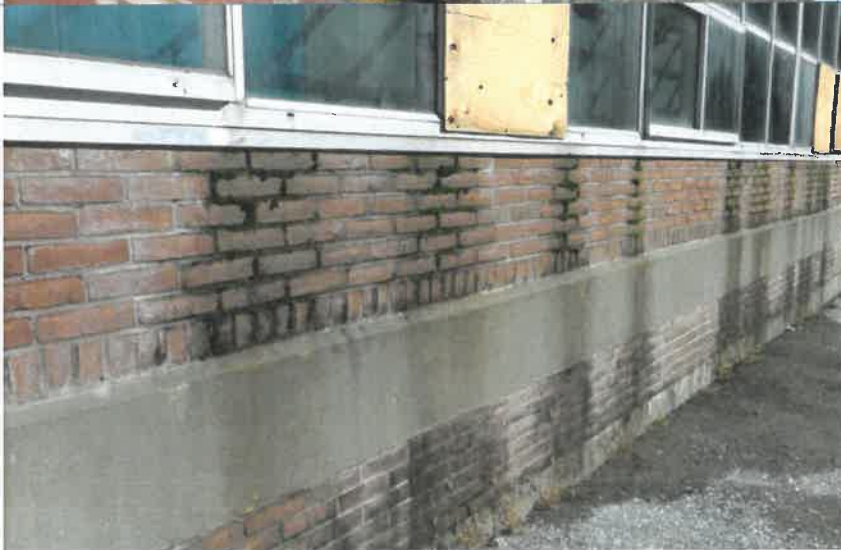
Photo # 10

The building's exterior walls are brick clad with masonry and terra cotta cornices, parapets, and similar details. Some minor mortar failures and evidence of water migration were noted (see photo 10). Overall, the brick cladding is in good condition.

The exterior of the recent addition is in good condition. Some mortar deterioration was noted on the West wall, below the window-well (see photo10).

West side recent addition - mortar deterioration.

5. Test and put into operation the gas-fired water heater (not currently in operation)
6. Re-point brick as needed, primarily on North side of building
7. Clean white roof to reduce summer time temperatures and extend the roof life

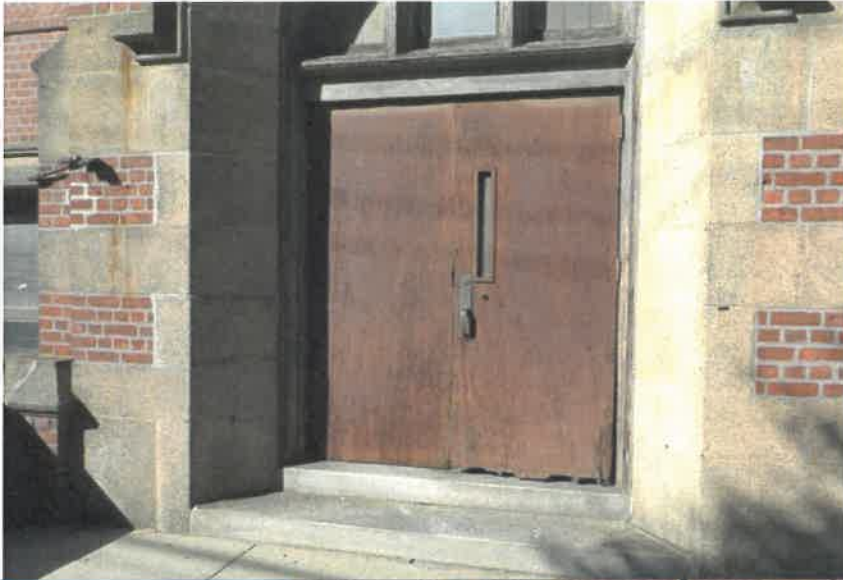
Photo # 11

Exterior doors are in operable condition but have been covered with plywood (see photo 11). The plywood is in poor condition and should be removed and replaced, or the doors restored to their

Exterior doors –
plywood covered.

8. Redo step-flashing on roof access structure
9. Replace roof drain covers as needed
10. Clean out boiler room and mechanical areas
11. Remove and replace plywood on exterior doors

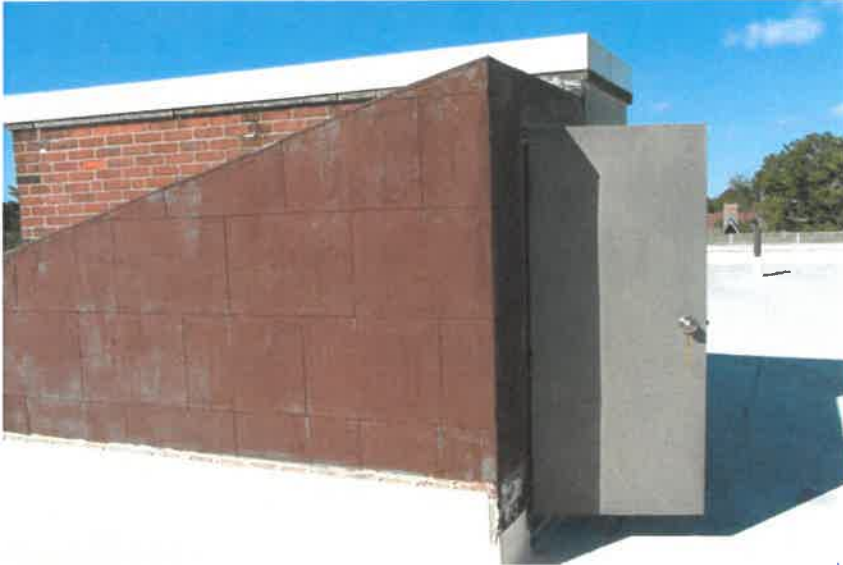
Photo # 23

Roof access is through an interior stairwell exiting directly onto the roof. The structure capping this stairwell appears to be tin-clad and the step-flashing shows some signs of deterioration (see photos 23-24).

Roof access structure.

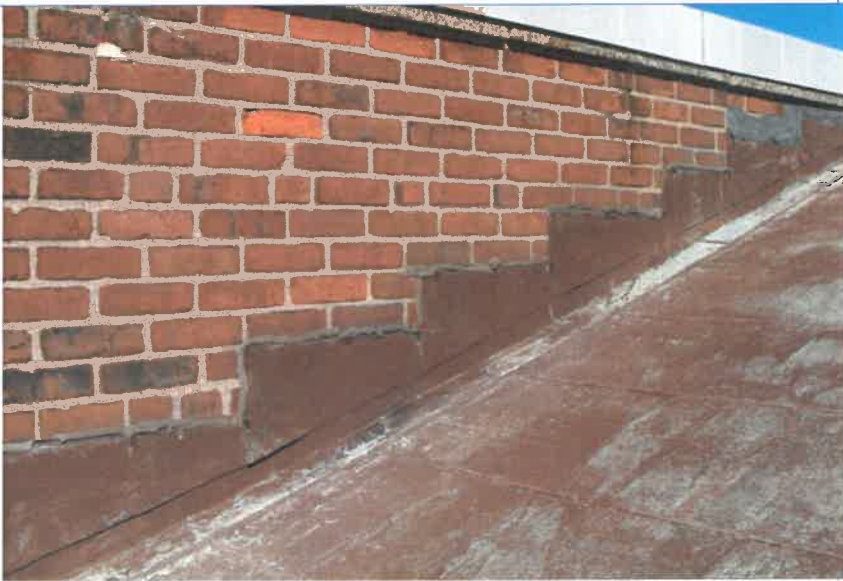
Photo # 24

Roof access structure — step flashing in poor condition.

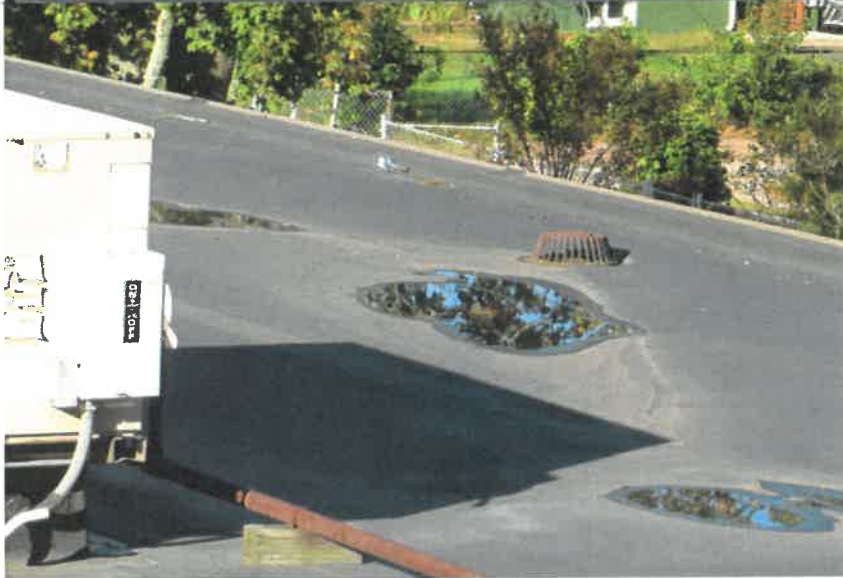
Photo # 30

The roof of the recent addition also appears to be in good condition. A small amount of ponding was observed near the roof drains, east of the roof-top HVAC (Heating, Ventilation and Air Conditioning) units (see photo 30). No leaks were evident in the classrooms or restrooms below, however. The hallway in the recent addition has light-framed continuous skylight roof systems (see photos 28 and 51) and the skylight has several broken panels (see photo 52).

Recent addition –
field of roof. Some
ponding noted.

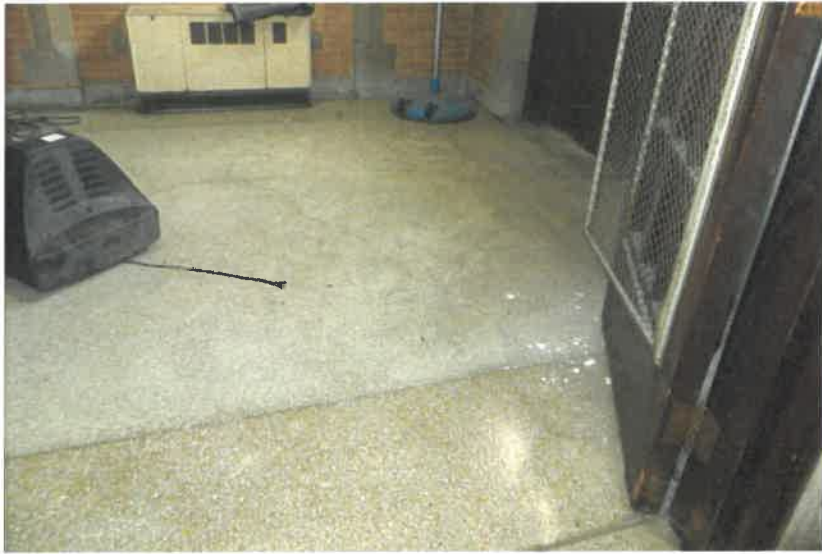
Photo # 35

The brick and masonry details are in good condition, as is the wood flooring in the main room (see photos 33-34). Terrazzo flooring in the vestibules has some cracking, but is otherwise in good condition (see photo 35). Interior doors and hardware are operable and in fair condition; some hardware may need to be replaced.

Vestibule floor.

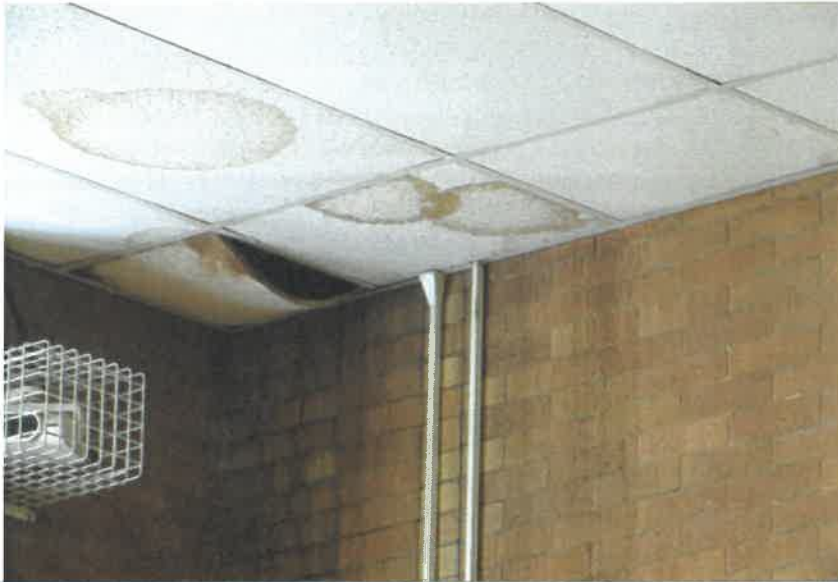
Photo # 37

Numerous leaks are evident in the suspended acoustical ceiling, primarily along the South side of the main room (see photos 37-39). The roof in this portion of the building appears to be in good condition. The source of the leaks may be ventilation louvers located above the South-facing windows located above the suspended acoustical ceiling (see photo 12). Additionally, the exterior sealant in some of the window transition assemblies has failed (see photo 9). A building envelope assessment should be completed for this portion of the building and the balance of the building if funding allows.

Auditorium –
building envelope
leaks. Note water
marks on brick
wall.

12. Repair or replace hardware on exterior doors as needed
13. Missing, broken or stained ceiling tiles should be replaced to facilitate leak detection (after sealant replacement on exterior walls completed)

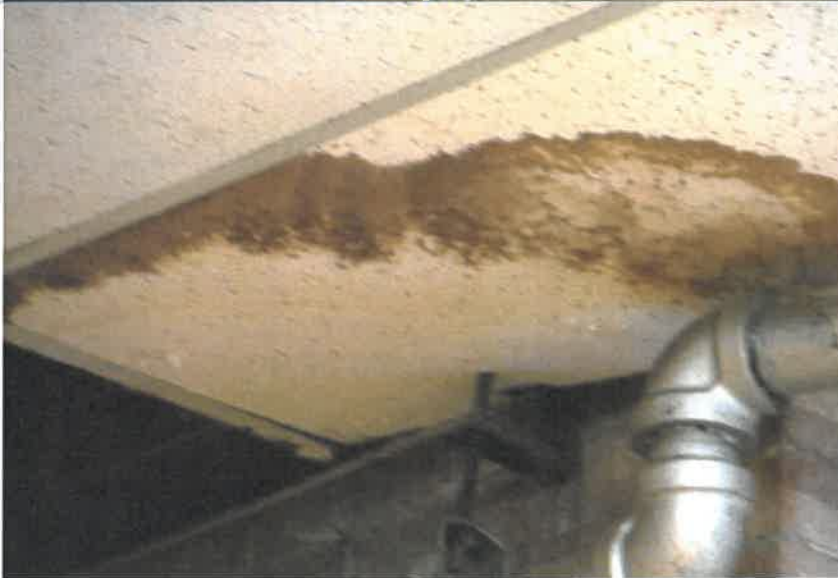
Photo # 38

Auditorium –
building envelope
leaks.

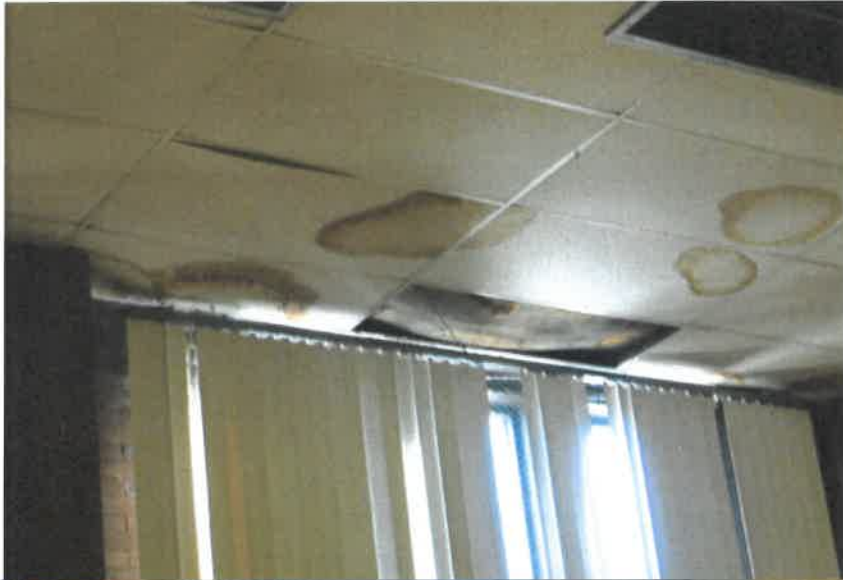
Photo # 39

Auditorium South side – building envelope leaks. Ventilation louver directly above windows pictured here.

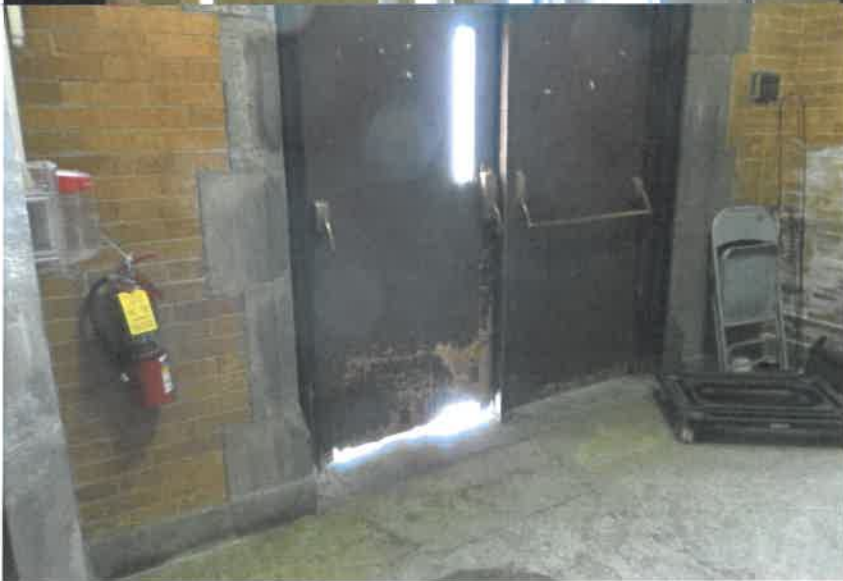
Photo # 40

original state. A few of the exterior doors are in very poor condition and should be replaced (see photo 40).

Some exterior doors in poor condition and missing hardware.

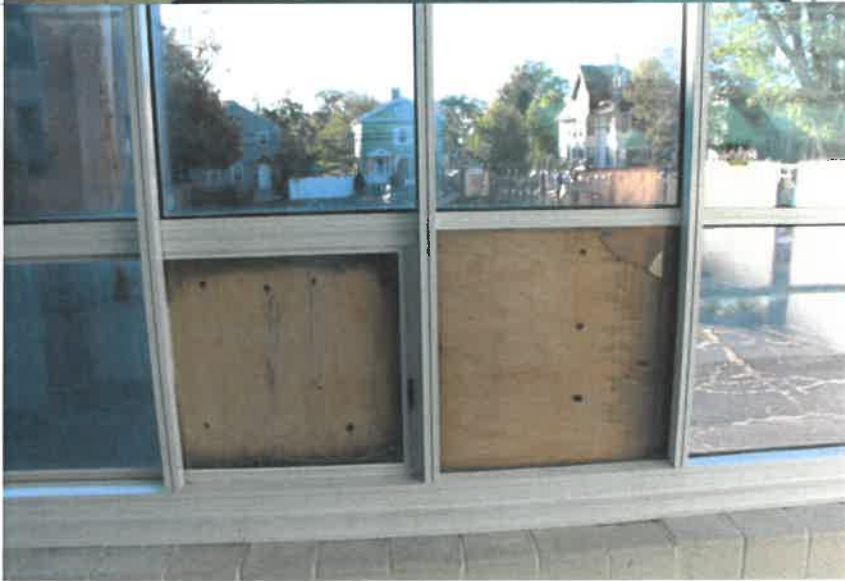
Photo # 52

Recent addition -
hallway. Broken
lights.

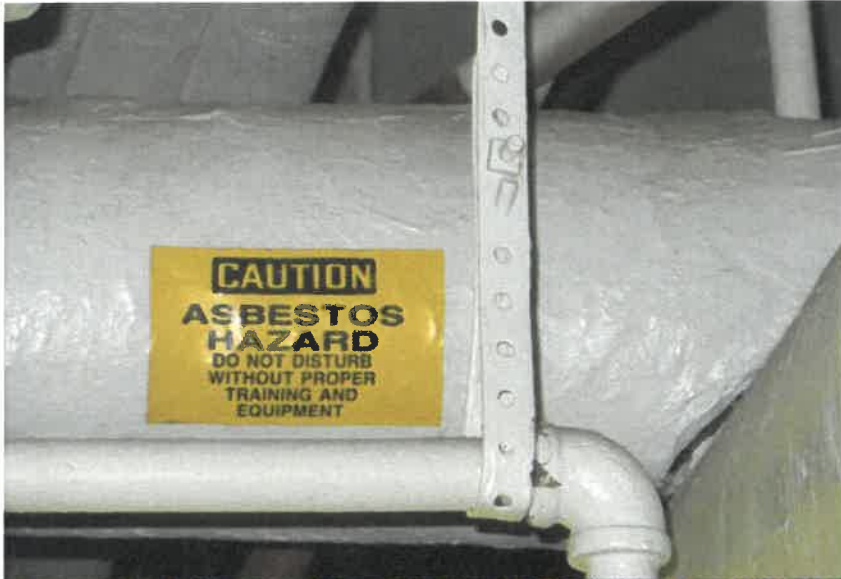
Photo # 57

pipng, traps, fittings, and convectors appear to be original but in working order (see photo 56). Some piping indicates asbestos insulation, but appears well encased in most areas (see photo 57).

Asbestos warning -
typical. Most areas
are well encased.
