Strong School Building

Facility Assessment – October 2012

69 Grand Avenue – New Haven - Connecticut

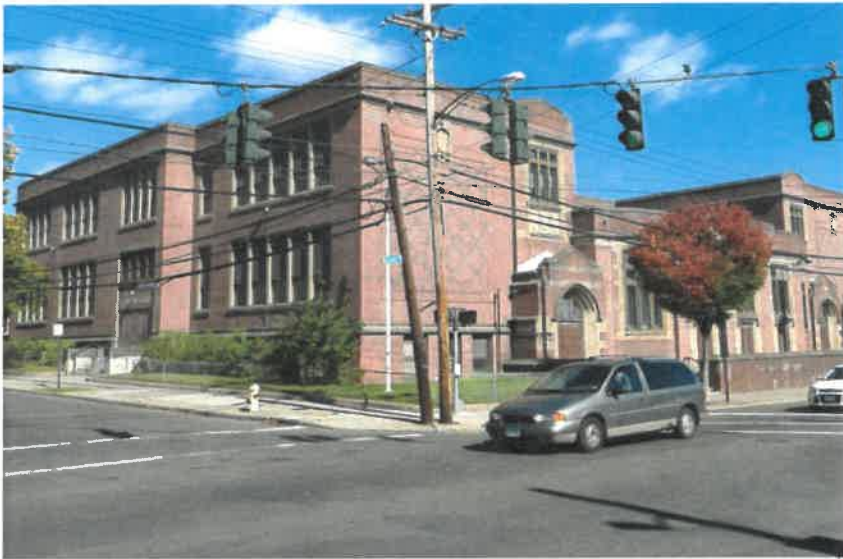
Photo # 1

South and West
sides of building
looking Northeast
(Grand Avenue and
Clinton Avenue).

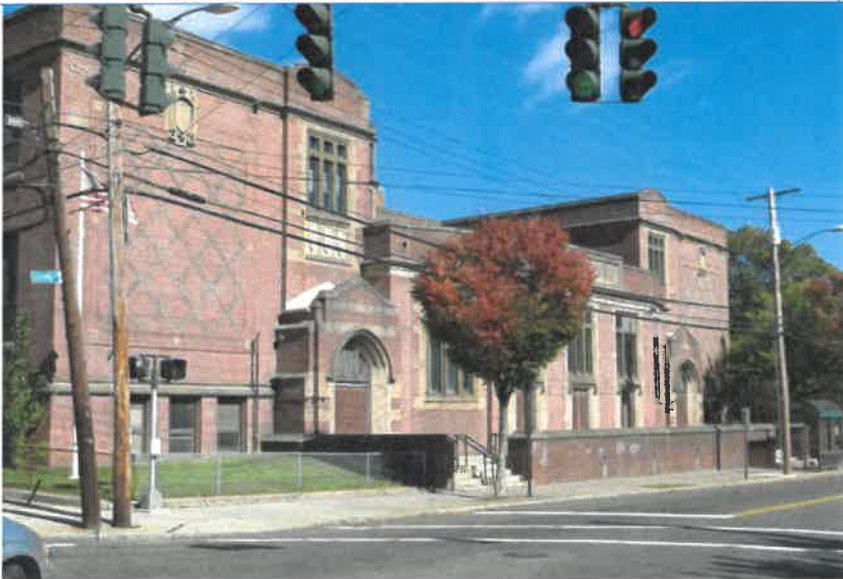
Photo # 2

South side of
building looking
North (Grand
Avenue).

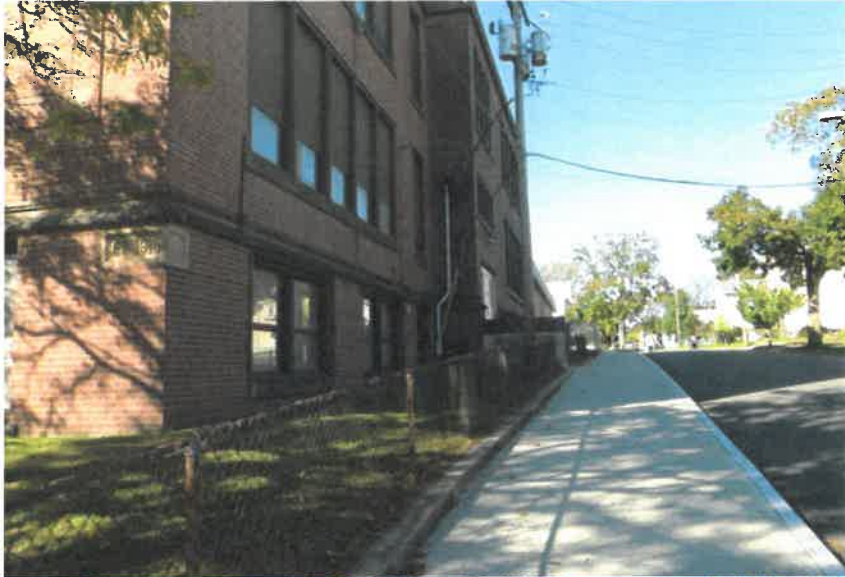
Photo # 3

Public sidewalks on Clinton Avenue and Grand Avenue are in good condition. Public sidewalk along Perkins Street appears to have been recently replaced. Curbs are in good condition and ADA compliant. (See photos 3, 4 and 6.)

East side of building looking North (Perkins Street).

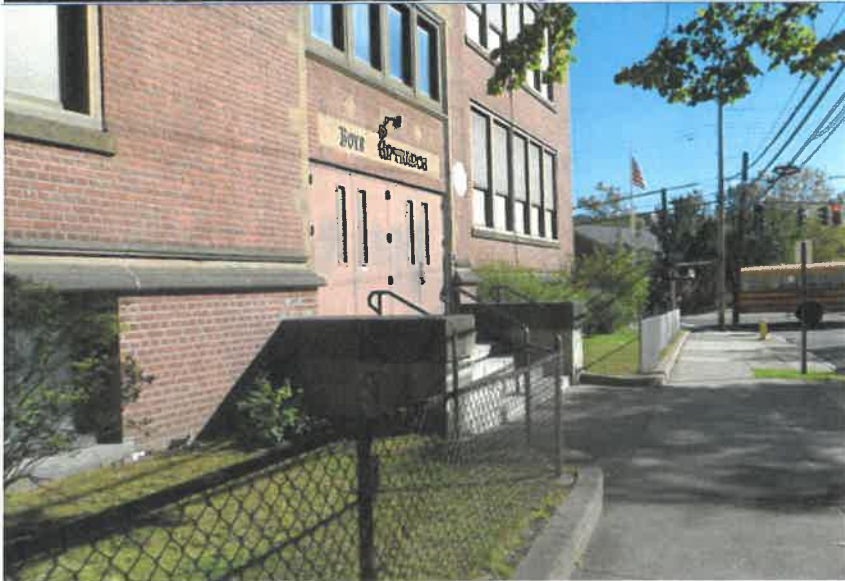
Photo # 4

West side of building looking South (Clinton Avenue).

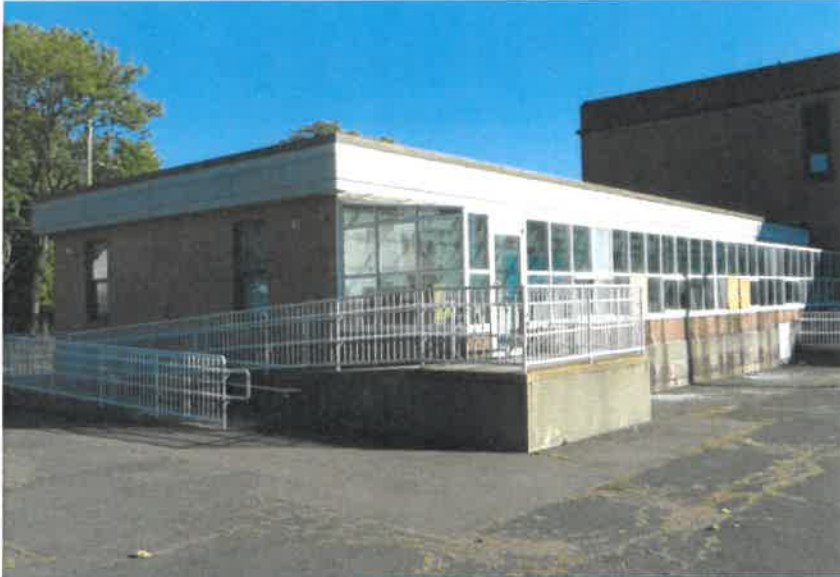
Photo # 5

Recent addition
West and North
sides looking
Southeast.

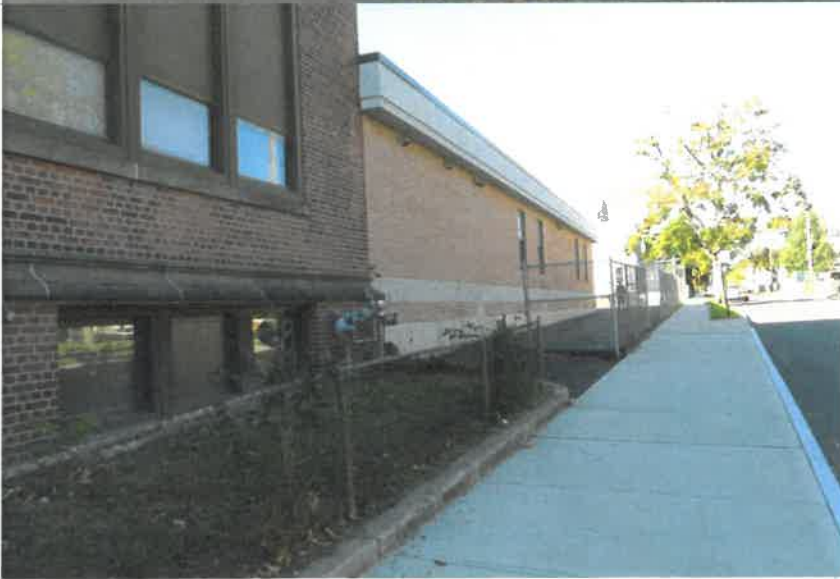
Photo # 6

Recent addition
East side looking
North (Perkins
Street).

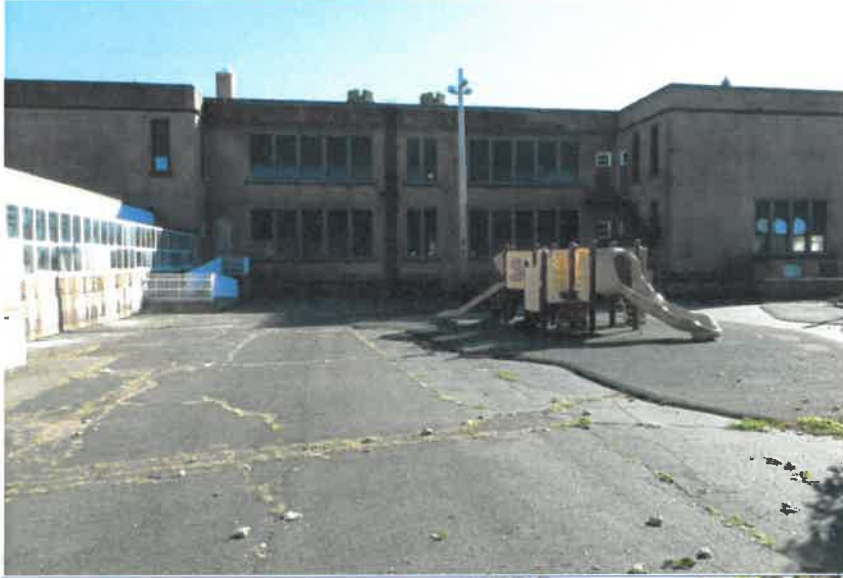
Photo # 7

North side looking
South.

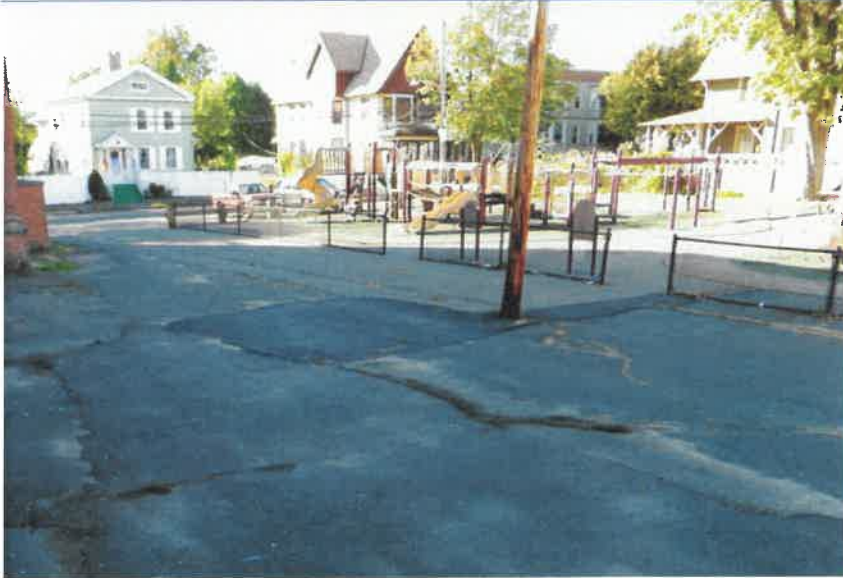
Photo # 8

Playground and
parking area
looking North.

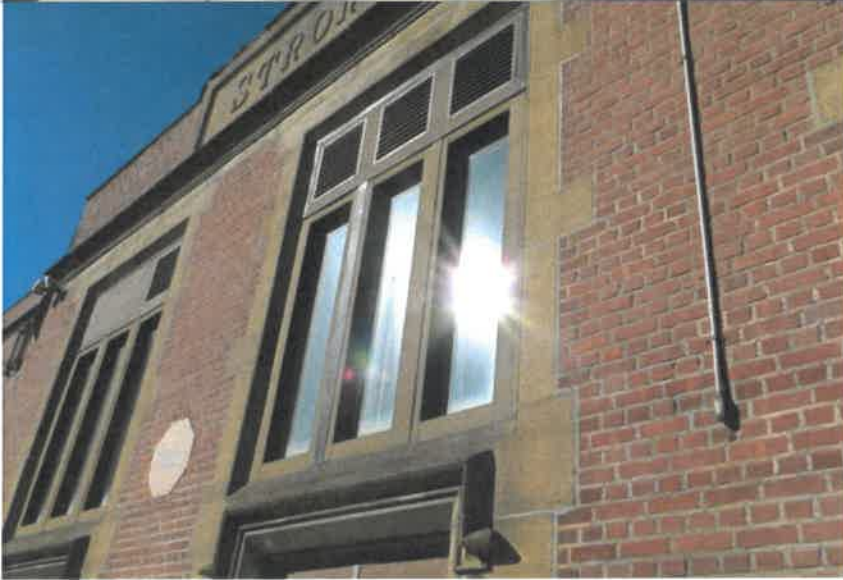
Photo # 12

Numerous leaks are evident in the suspended acoustical ceiling, primarily along the South side of the main room (see photos 37-39). The roof in this portion of the building appears to be in good condition. The source of the leaks may be ventilation louvers located above the South-facing windows located above the suspended acoustical ceiling (see photo 12). Additionally, the exterior sealant in some of the window transition assemblies has failed (see photo 9). A building envelope assessment should be completed for this portion of the building and the balance of the building if funding allows.

South side (Grand
Avenue) windows
and ventilation
louvers.

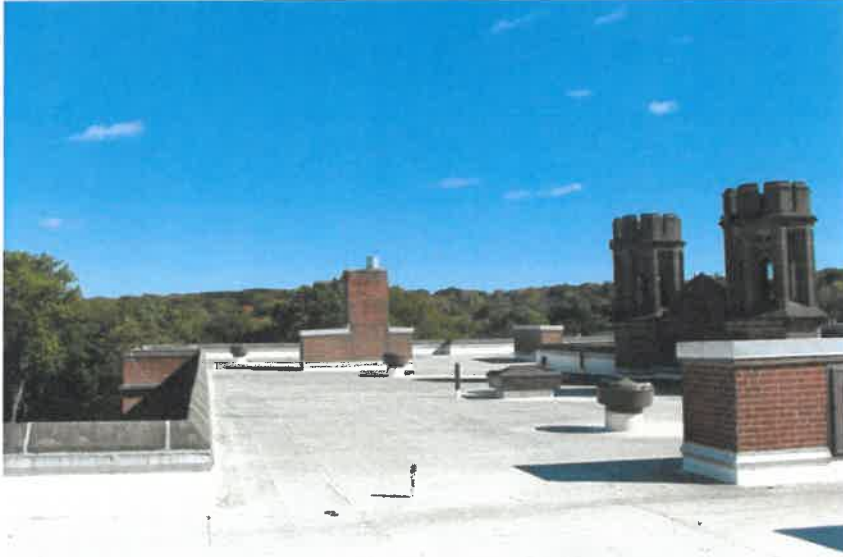
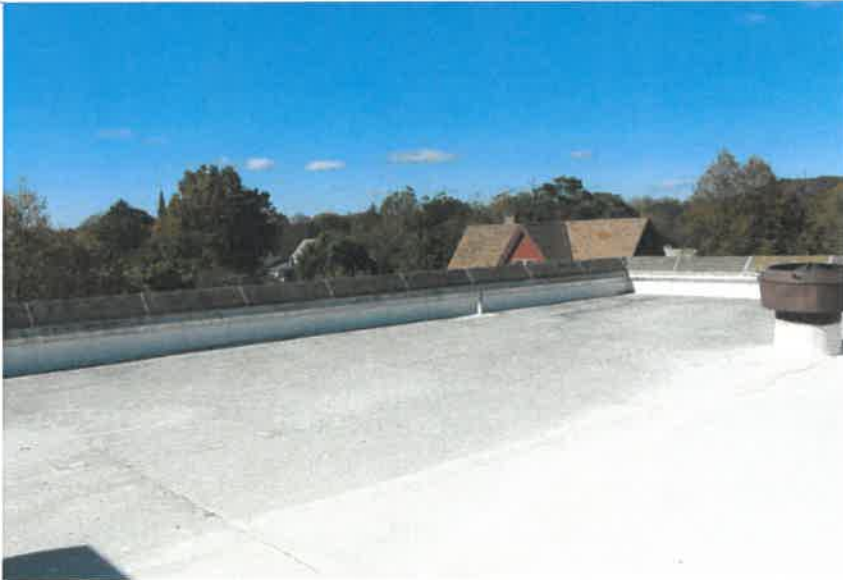
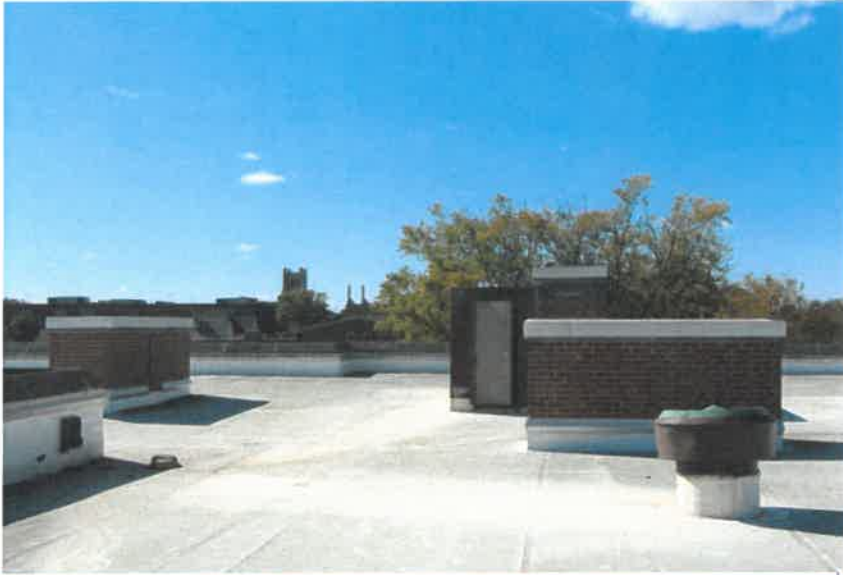
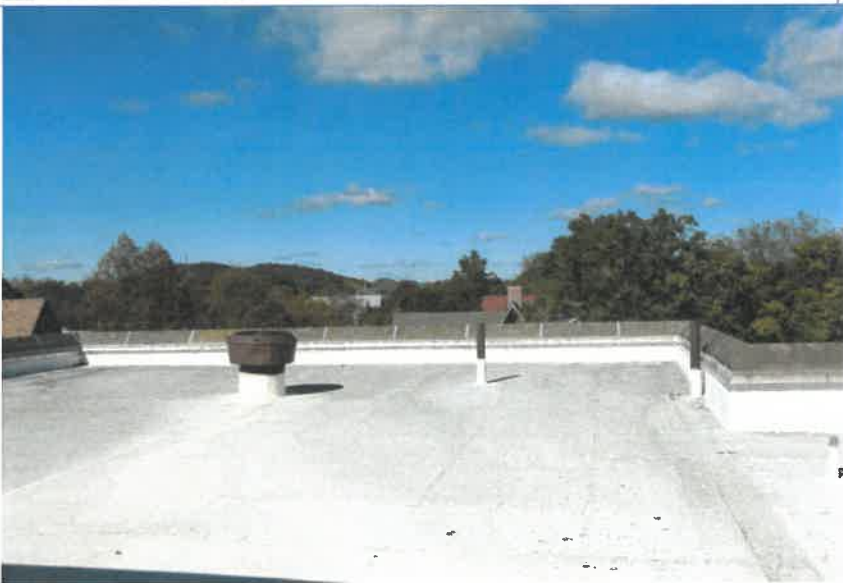
The field of the roof appears to be water tight and in good condition. The roofing membrane did not show signs of deterioration or failure. All lap joints are fully sealed and in good condition. No significant ponding was noted. (See photos 13-16.)

Field of main roof
looking East.

Field of main roof
looking Northeast.

Field of main roof
looking West.

An infrared moisture survey is recommended to detect any moisture that may be trapped under the roof membrane. Moisture trapped under the roof membrane dramatically reduces the effectiveness of the roof insulation and contributes to deterioration of the roof deck, insulation and membrane.

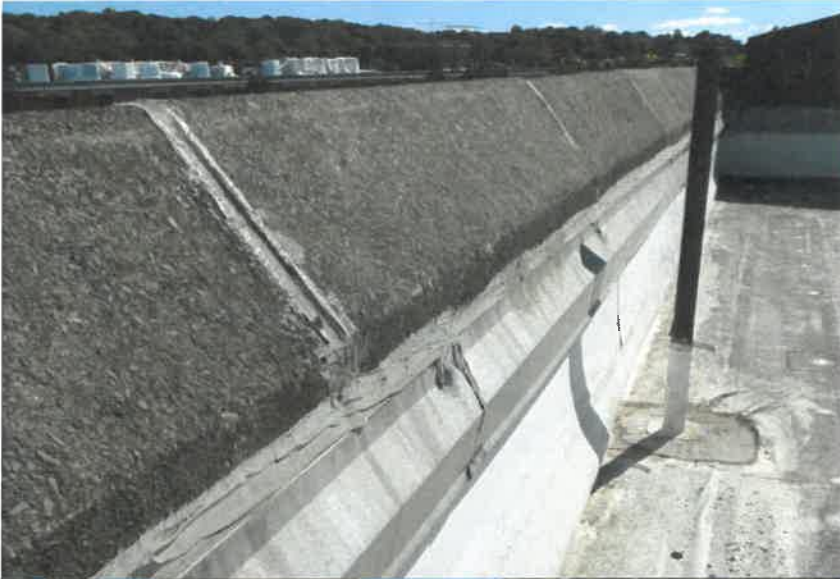
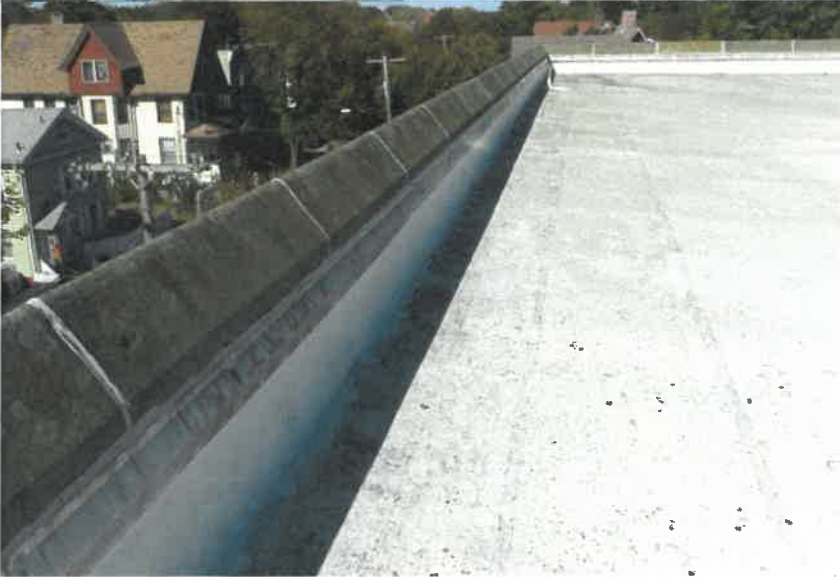
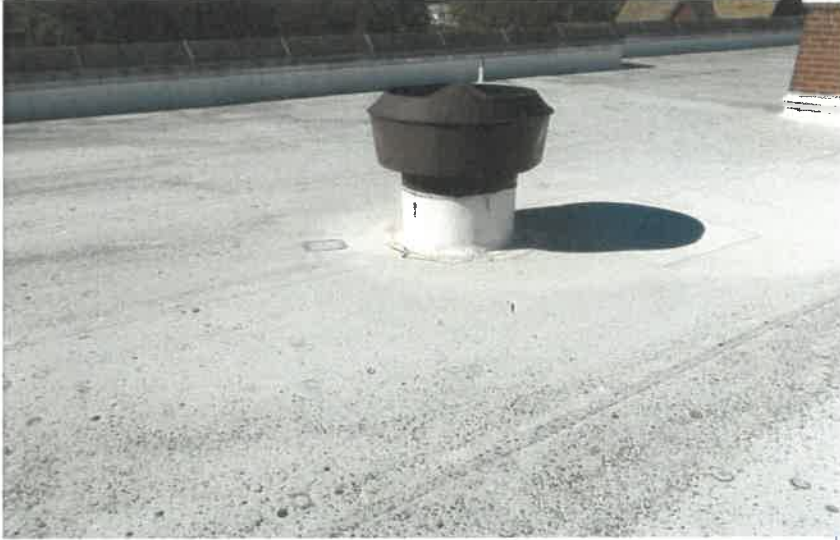
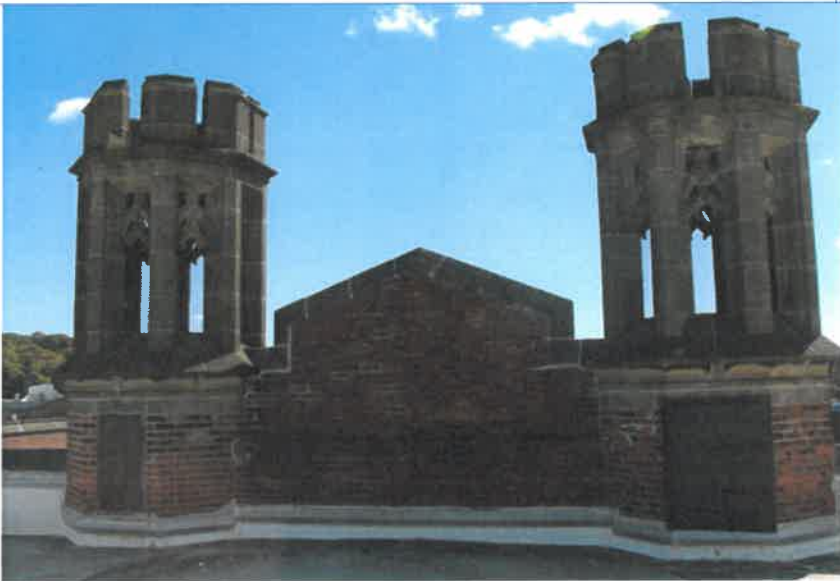
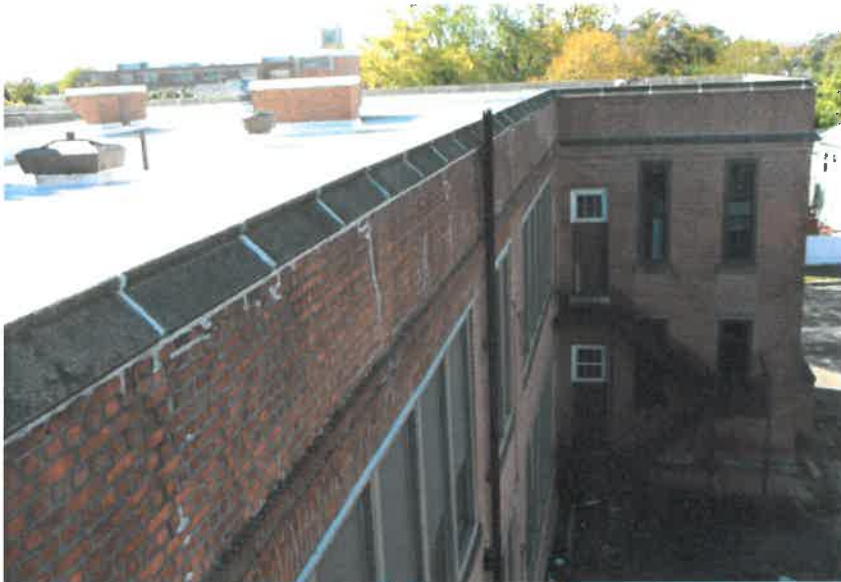
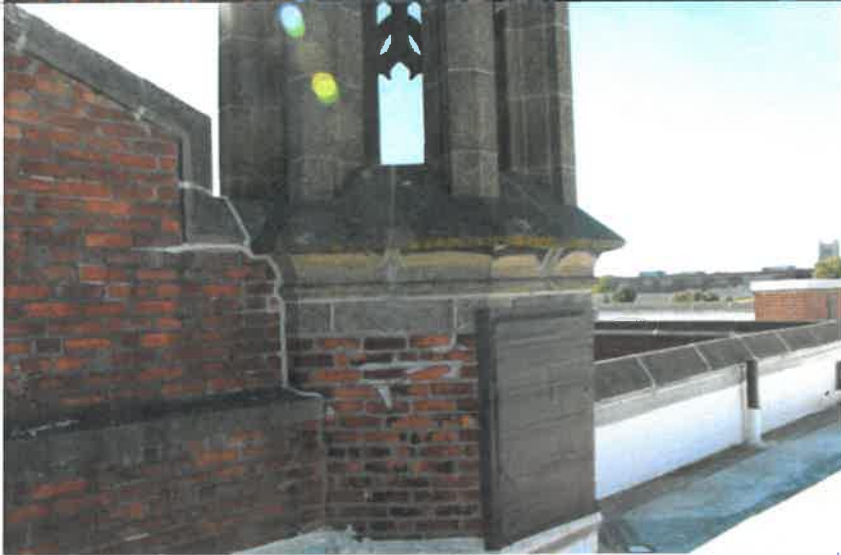
The fully adhered EPDM roofing membrane appears to have been installed over mechanically-fastened insulation board. It is not clear if the pre-existing built-up roofing system was removed. Parapet walls and coping are in good condition. Roof penetrations are properly flashed and in good condition. (See photos 17-22.)

Parapet wall and
vent pipe
penetration detail
(typical).

Parapet wall
(typical).

Exhaust fan curb detail (typical).

Parapet wall and ventilation shafts.

Parapet wall.

Parapet wall and
ventilation shafts.
Sealed access
panels.

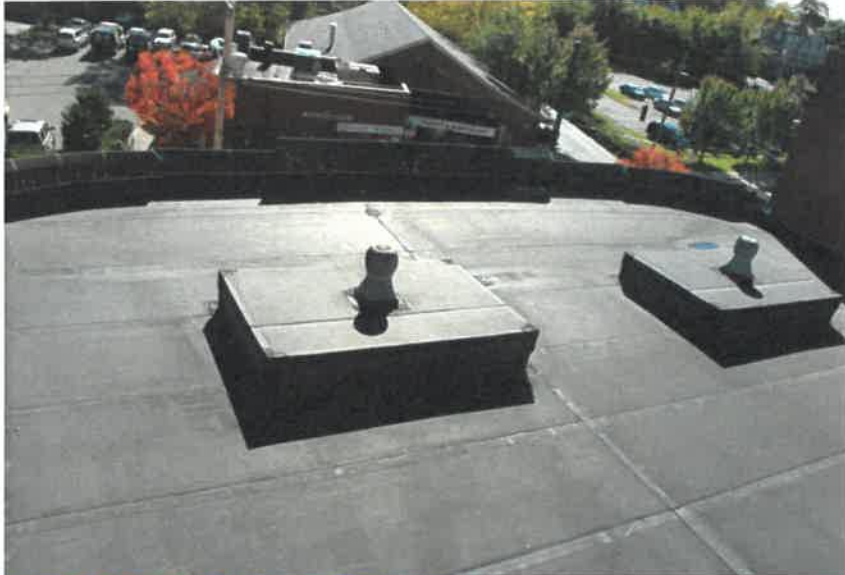
Photo # 25

Roof of auditorium
looking South.

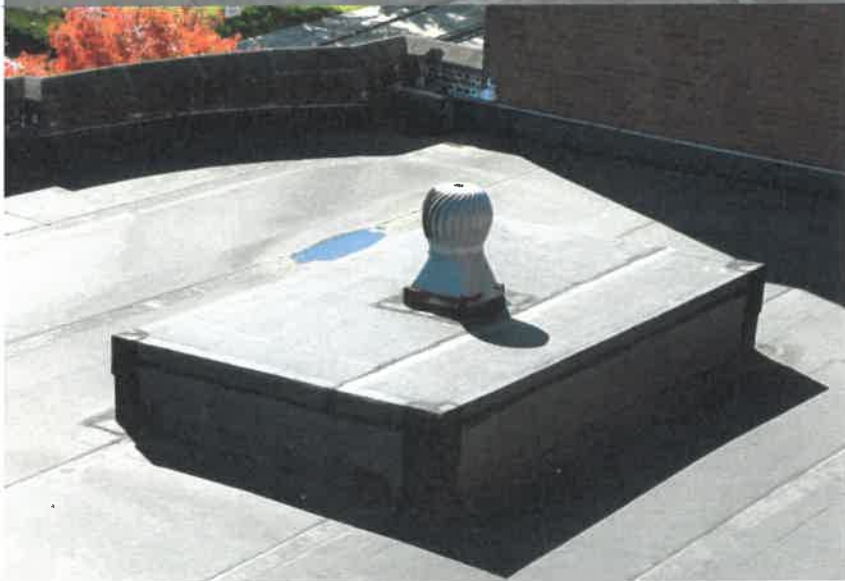
Photo # 26

Roof of auditorium
looking Southwest.

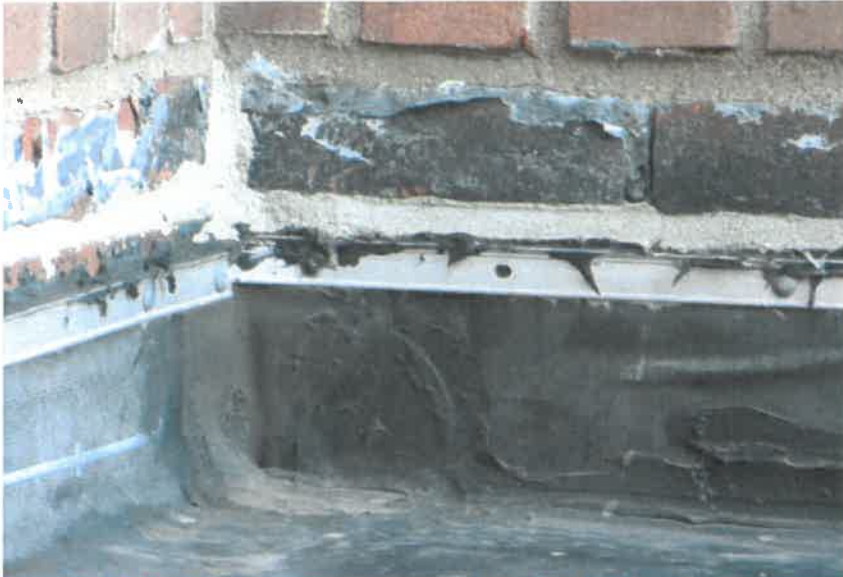
Photo # 27

Roof of auditorium
- parapet wall
(typical).

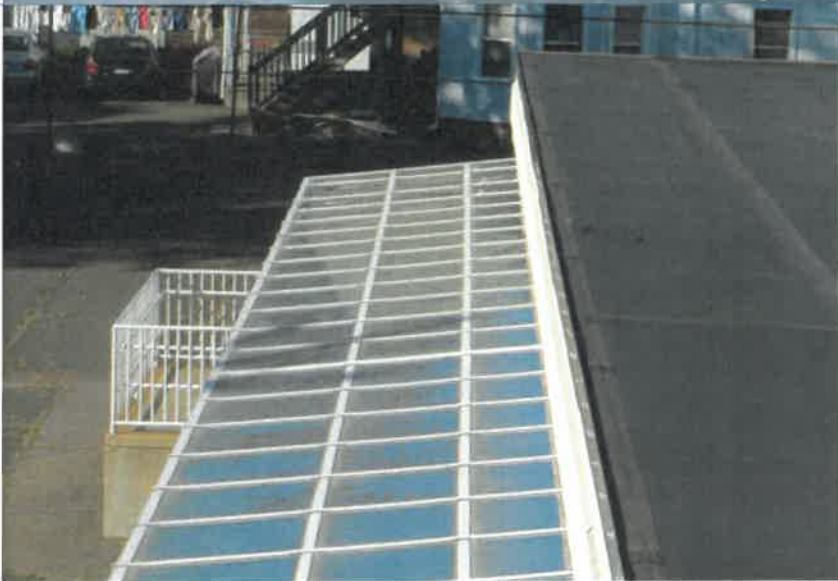
Photo # 28

The roof of the recent addition also appears to be in good condition. A small amount of ponding was observed near the roof drains, east of the roof-top HVAC (Heating, Ventilation and Air Conditioning) units (see photo 30). No leaks were evident in the classrooms or restrooms below, however. The hallway in the recent addition has light-framed continuous skylight roof systems (see photos 28 and 51) and the skylight has several broken panels (see photo 52).

Recent addition –
light-framed
continuous skylight
roof system.

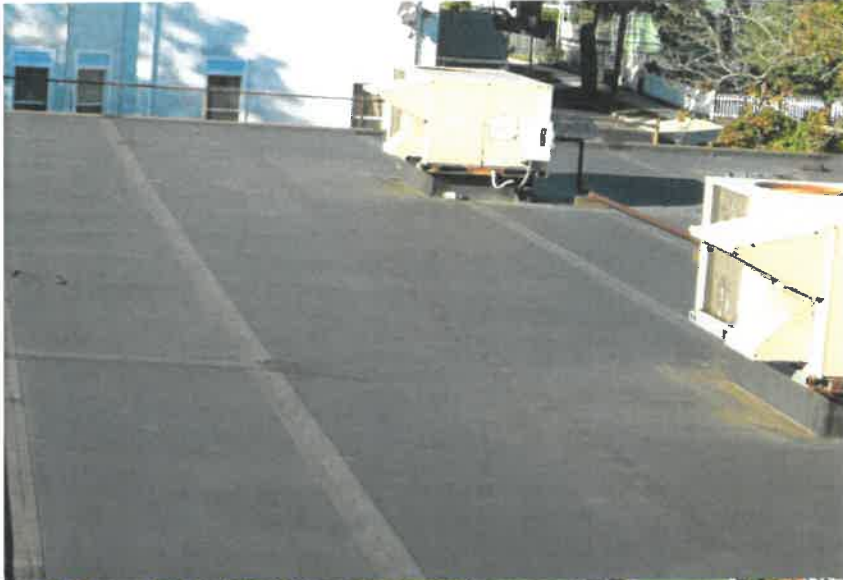
Photo # 29

Recent addition –
field of roof.

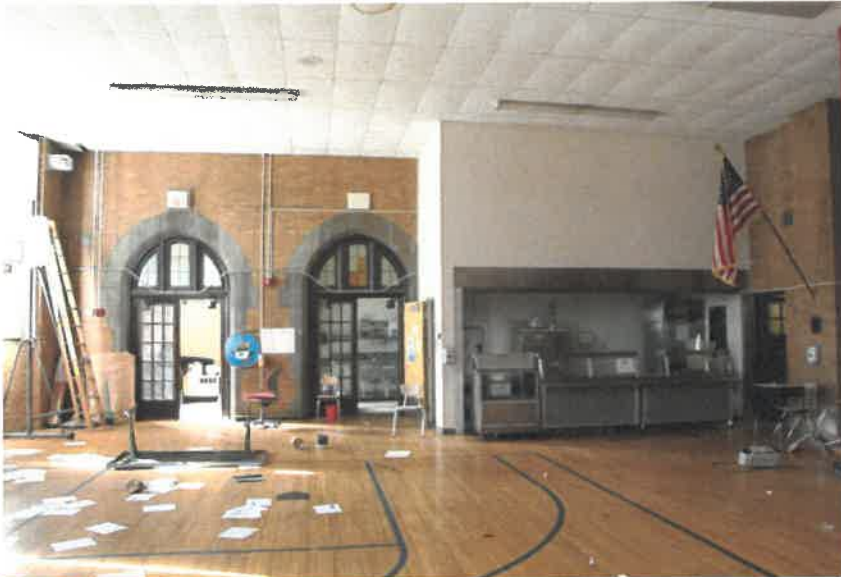
Photo # 31

Auditorium interior
looking West.

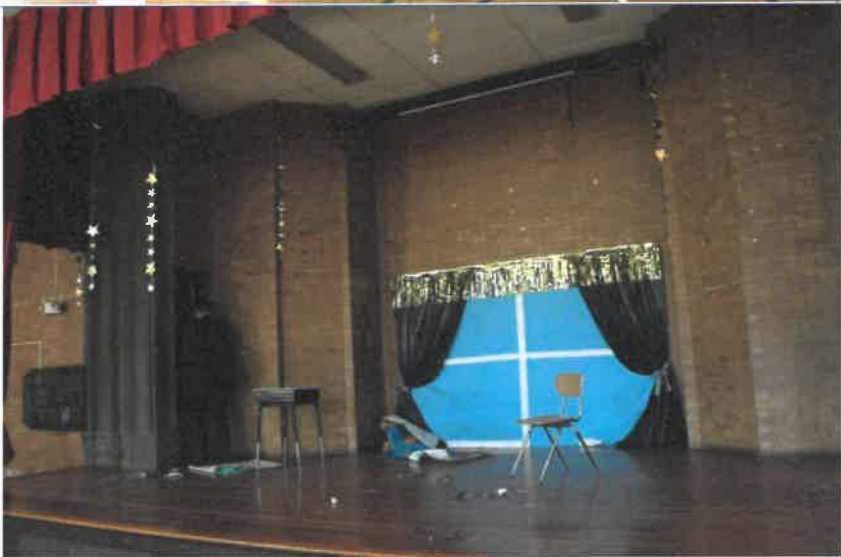
Photo # 32

Auditorium interior
and stage looking
North.

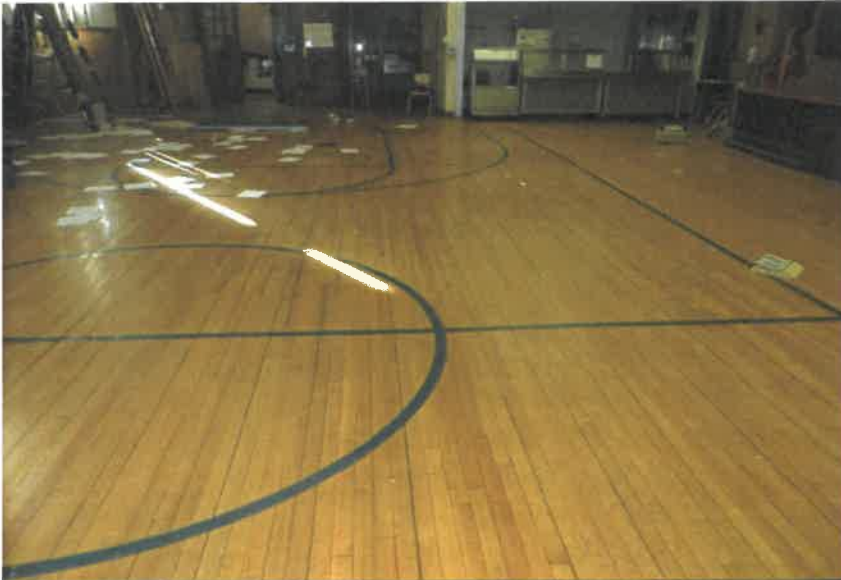
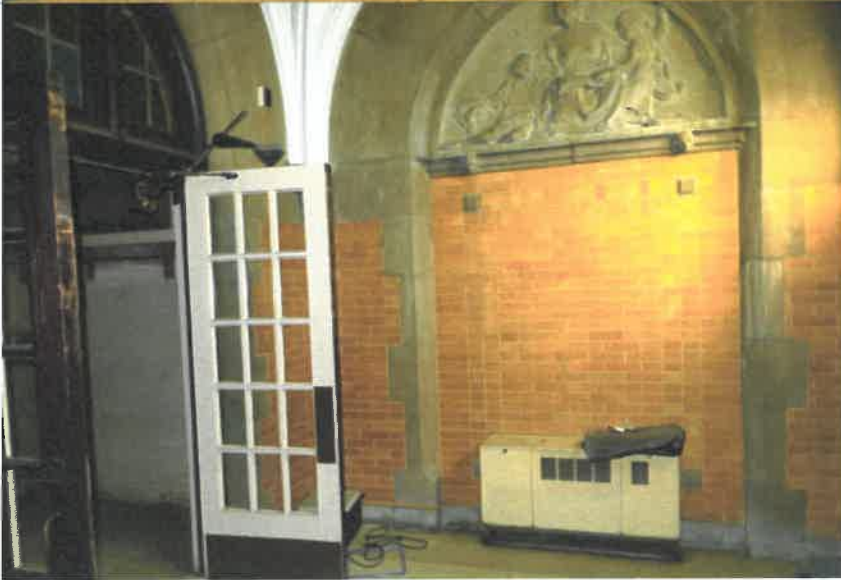
The brick and masonry details are in good condition, as is the wood flooring in the main room (see photos 33-34). Terrazzo flooring in the vestibules has some cracking, but is otherwise in good condition (see photo 35). Interior doors and hardware are operable and in fair condition; some hardware may need to be replaced.

Auditorium wood
floor looking West.

Vestibule
Southeast entrance
from Grand
Avenue.

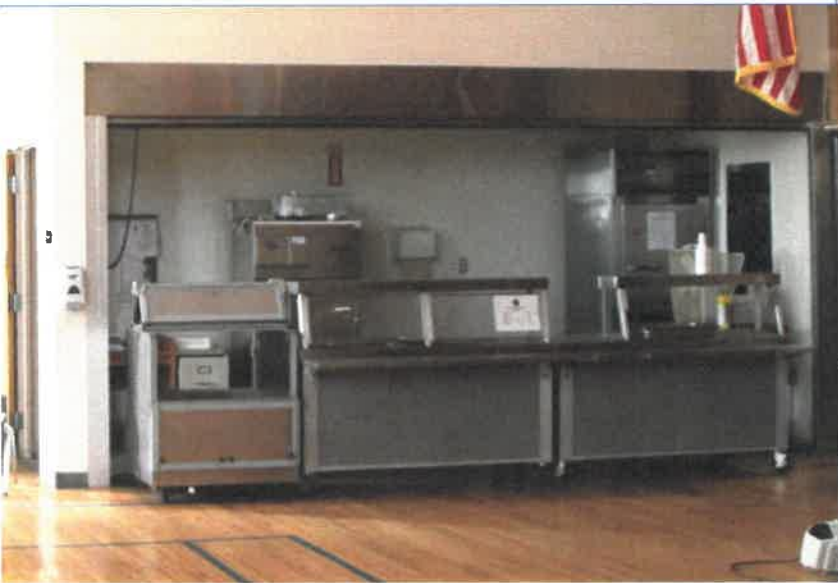
Photo # 36

The auditorium is a single-story portion of the building filling in the lower portion of the H layout; entrance is from Grand Avenue. The interior wall finishes are brick with masonry and terra cotta details. A suspended acoustical ceiling has been added in the main room. Entrance areas have their original plaster and tin ceilings. Flooring is wood in the main room and terrazzo in the entrance vestibules. (See photos 31-34.) A portion the main room and vestibule has been converted for use as a commercial kitchen, including a walk-in cooler (West side – Clinton Avenue – see photo 36).

Auditorium –
commercial kitchen
West side of main
room.

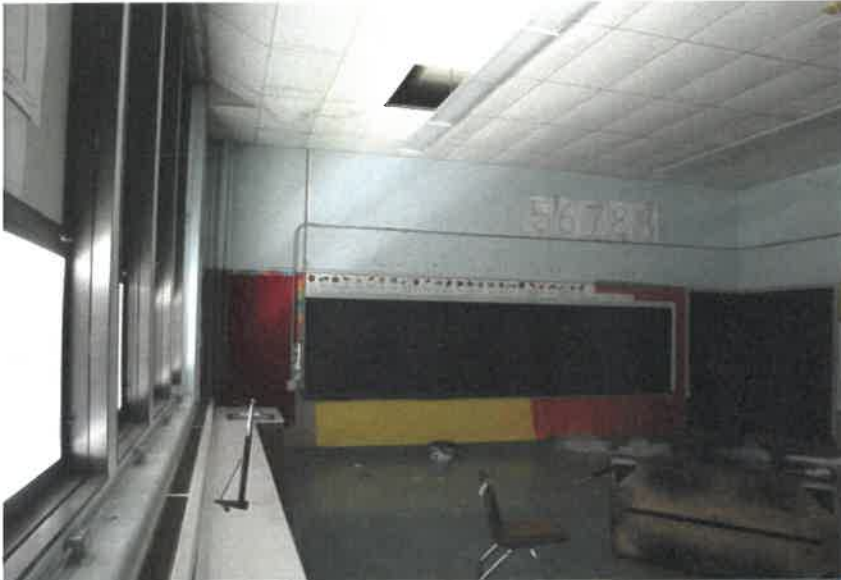
Photo # 41

The building has extensive signs of interior water leaks but no evidence indicates that these leaks are from current roofing failures. (See Photos 37-39, 41 and 46.)

Classroom -
typical.

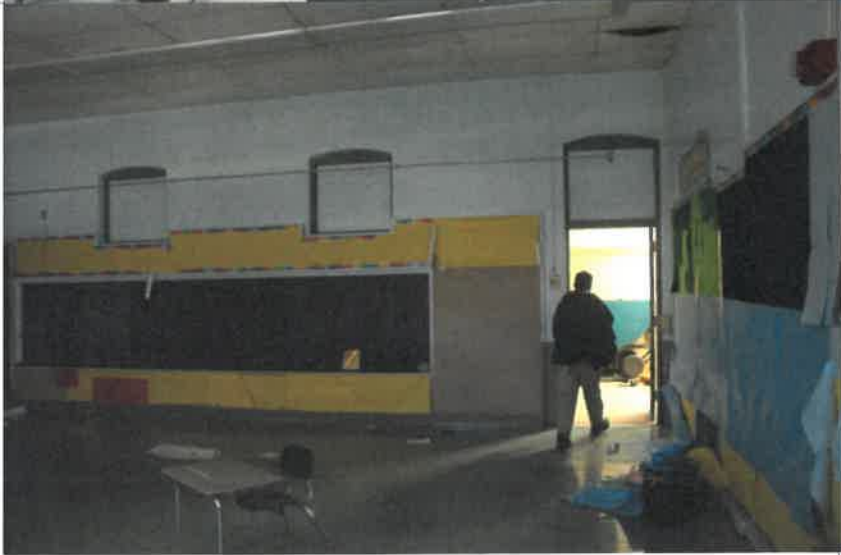
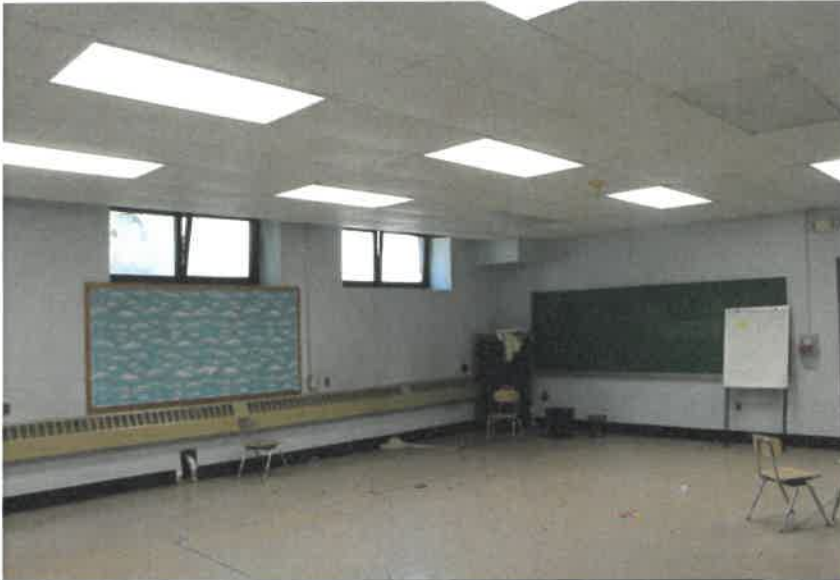
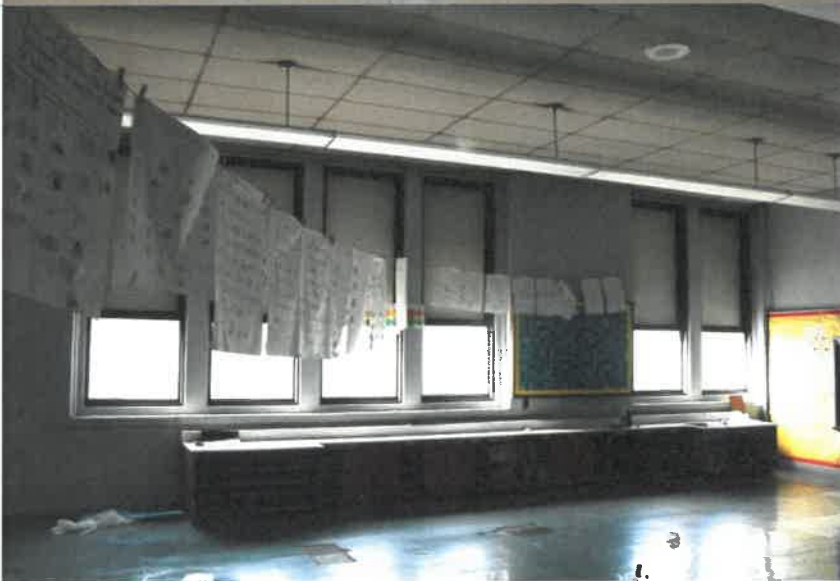
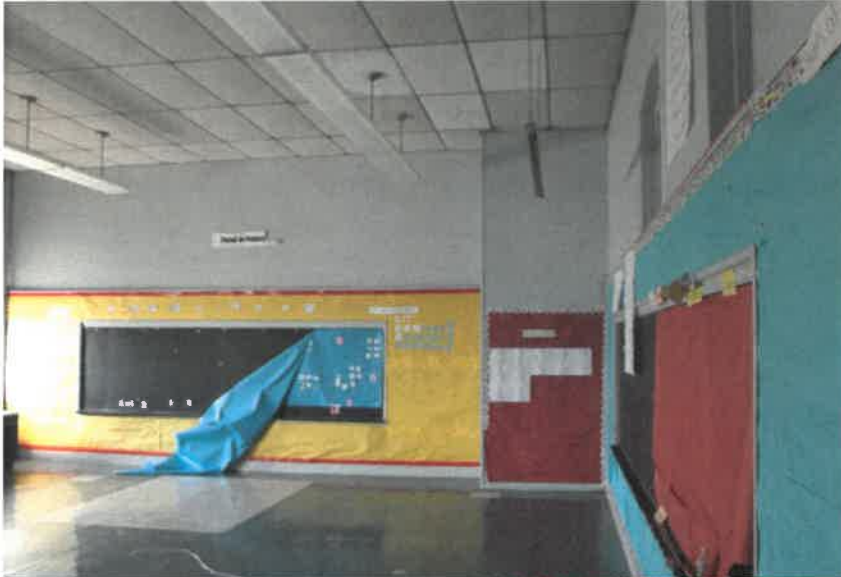
Classroom -
typical.

Classroom below
grade - typical.

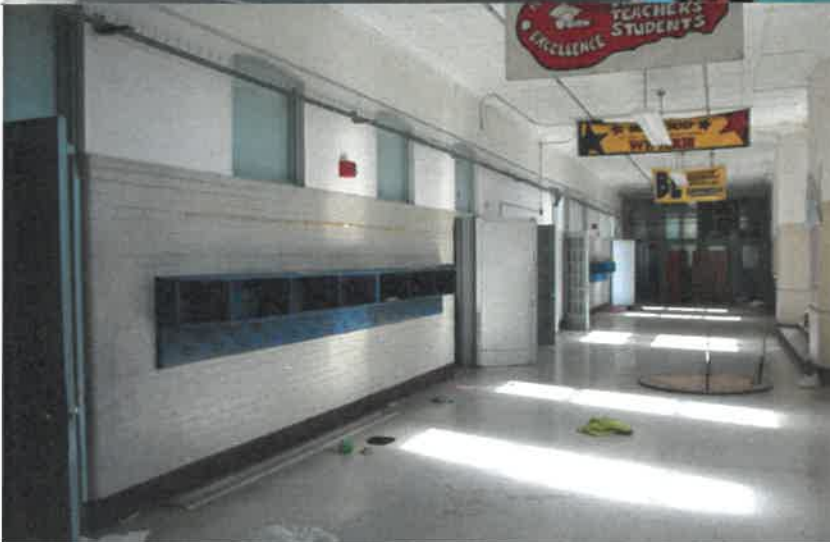
Photo # 46

Category 5 (Cat 5) wiring, commonly used for computer networks, has been installed throughout the facility (see photos 46, and 71-72). Cable trays mounted in the hallways provide ready access to the wiring and rack-mounted switches are still in place in the administrative office.

Hallway -typical.

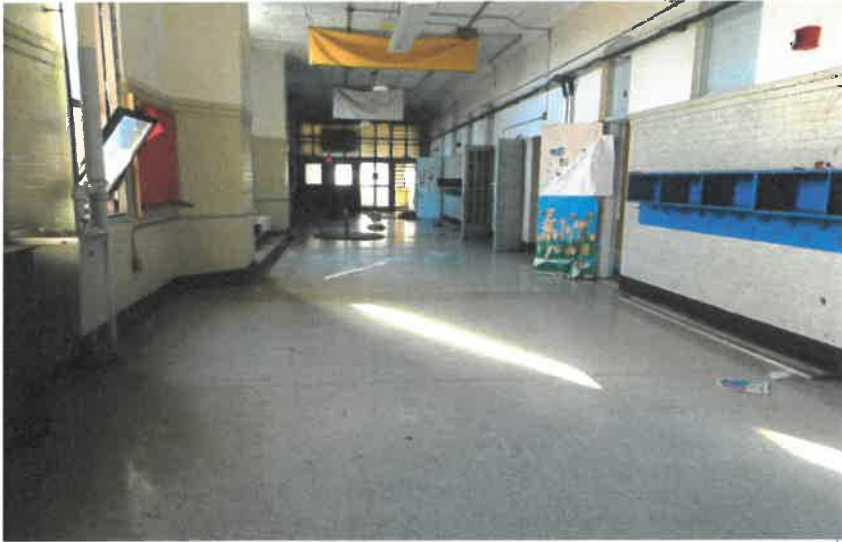
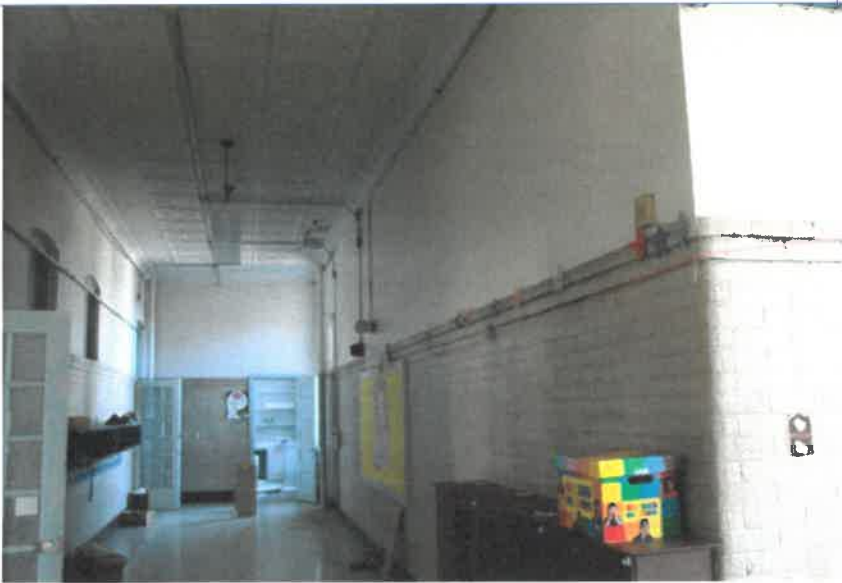
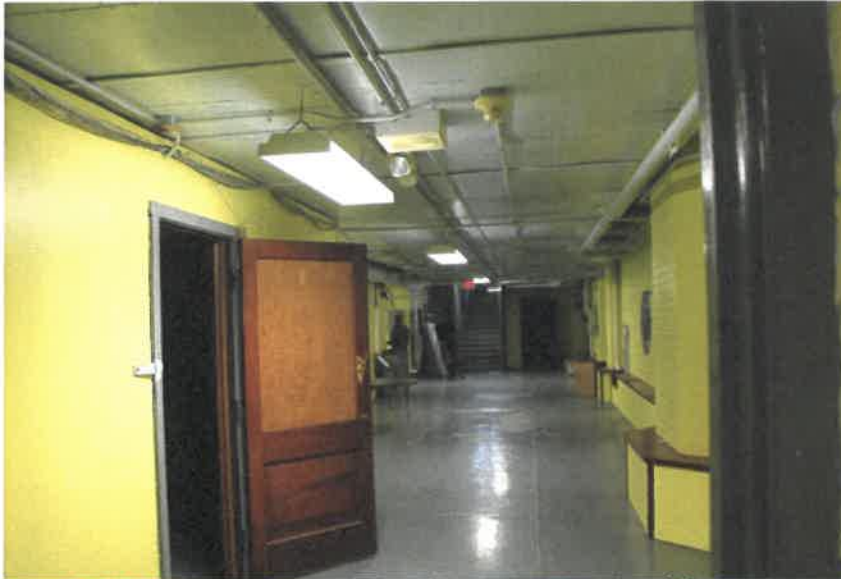
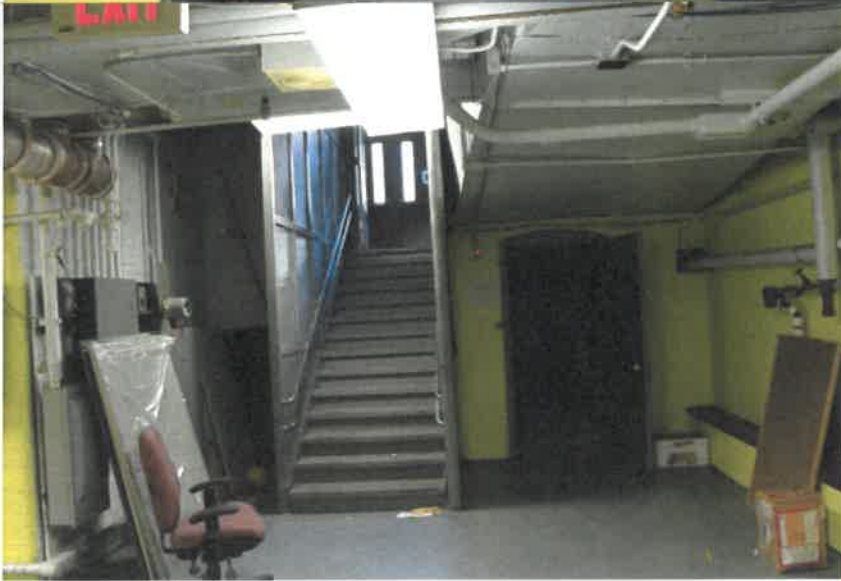
Hallway -typical.

Hallway below
grade - typical.

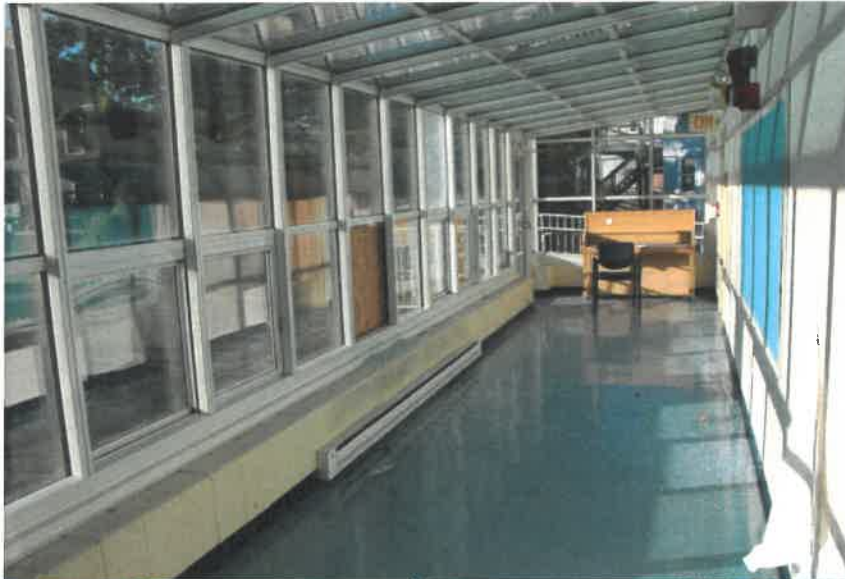
Photo # 51

Recent addition -
hallway.

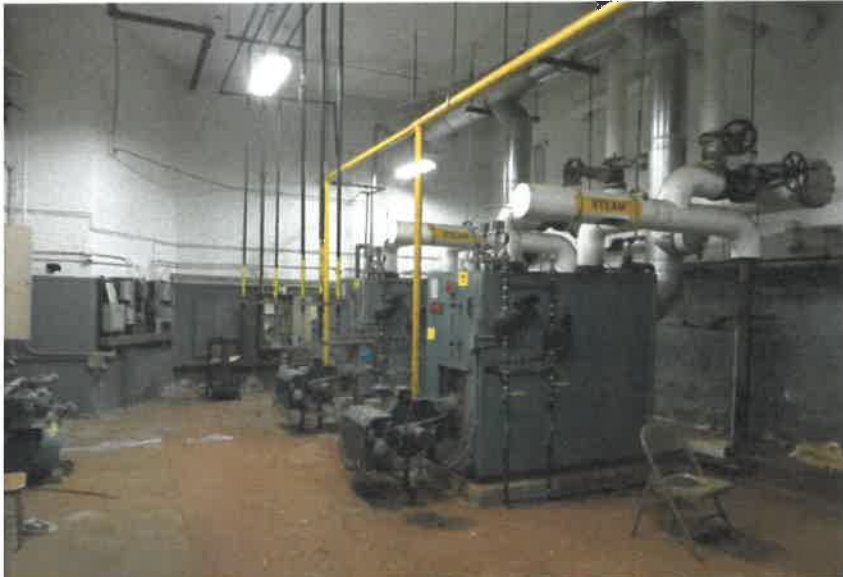
Photo # 53

Boiler room
looking Southeast.

The facility boiler room and mechanical areas should be cleaned out to facilitate servicing of mechanical equipment and reduce fire risk. A preventative maintenance program should be put in place for HVAC (Heating, Ventilation and Air Conditioning) equipment to reduce operating and repair costs. A survey of the existing building controls system should be completed to ensure proper operation and increase energy efficiency.

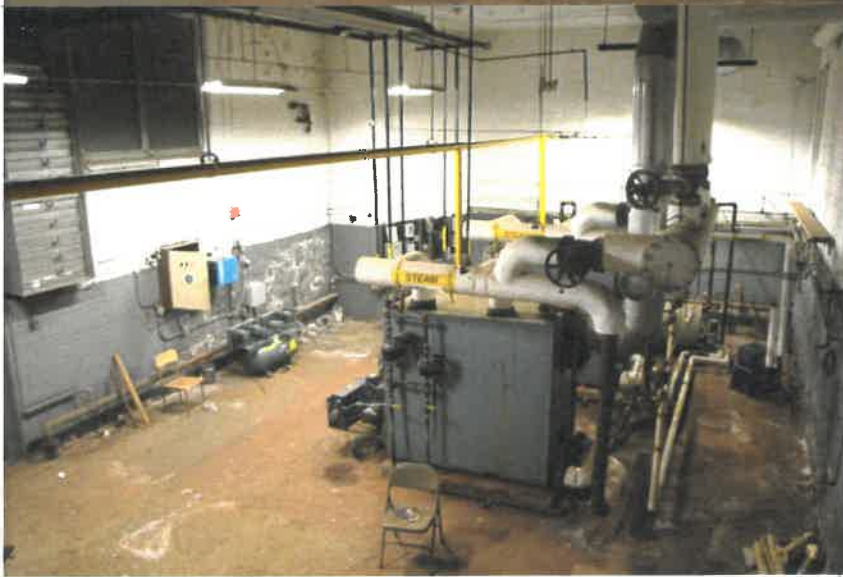
Photo # 54

Boiler room
looking Northeast

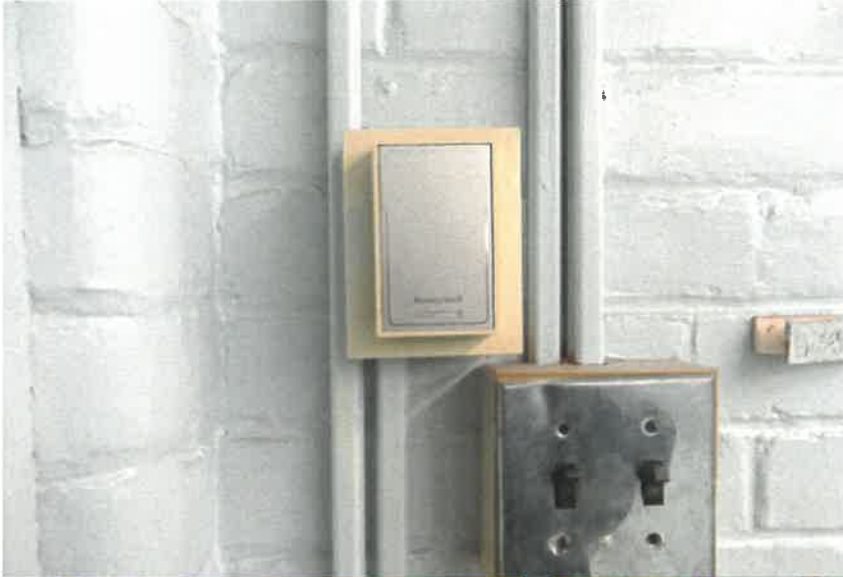
Photo # 55

JCI /Honeywell
controls - typical

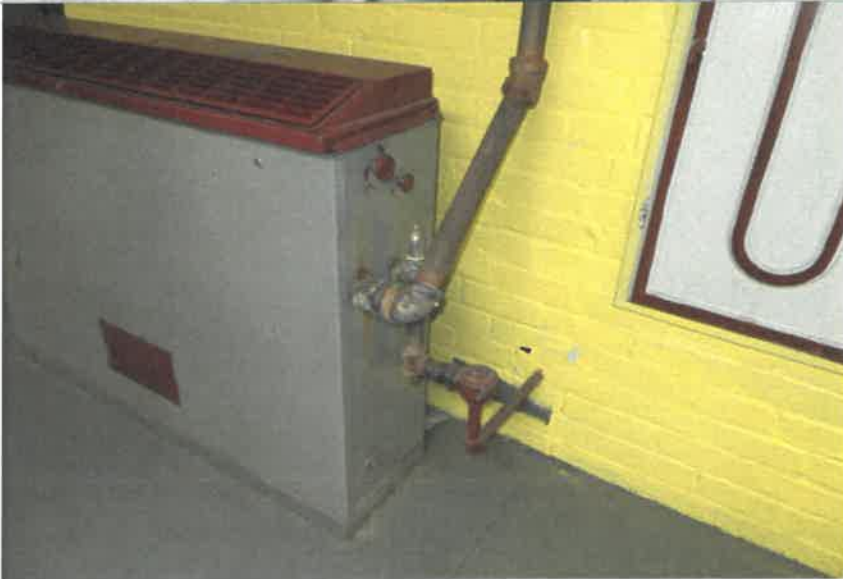
Photo # 56

pipng, traps, fittings, and convectors appear to be original but in working order (see photo 56). Some piping indicates asbestos insulation, but appears well encased in most areas (see photo 57).

Steam convectors,
fittings and traps -
typical.
