Strong School Building

Facility Assessment – October 2012

69 Grand Avenue – New Haven - Connecticut

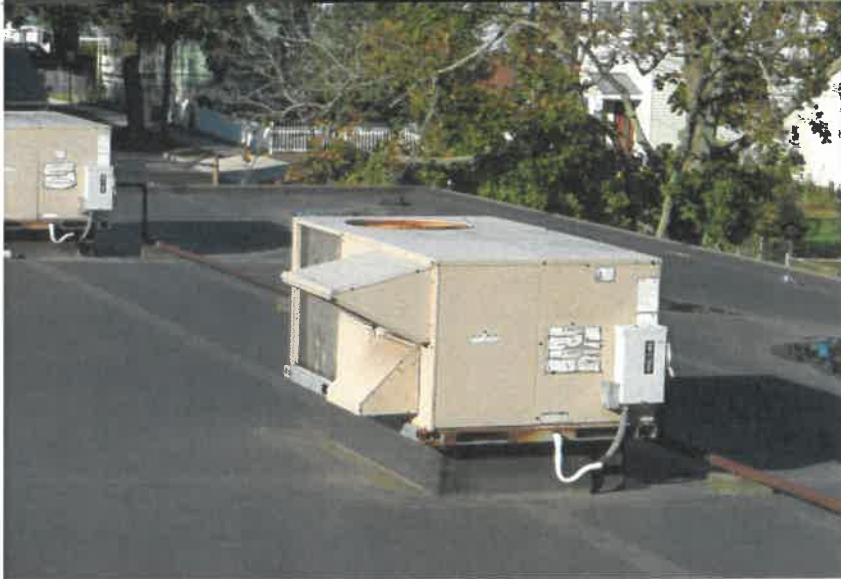
Photo # 58

The recent addition has two 5-7 ton roof-top package units, which provide heating and air-conditioning (see photo 58). Units were not directly accessible but seem to be fully operational with the exception of some damage to thermostats in the classrooms served. Supplemental electric baseboard heat is installed in the hallway and restrooms.

Recent addition –
Roof Top Unit
(RTU's) – 5-7 ton.

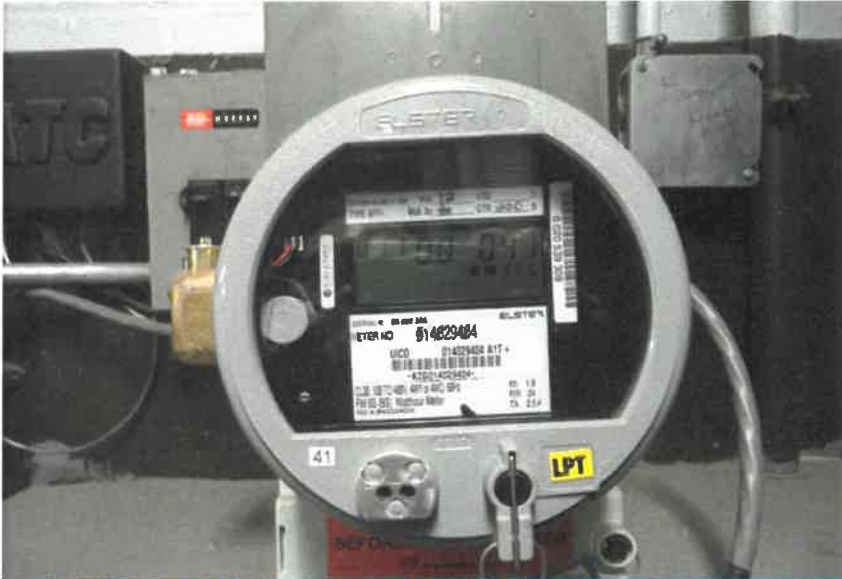
Photo # 59

400 Amp single-phase electrical service.

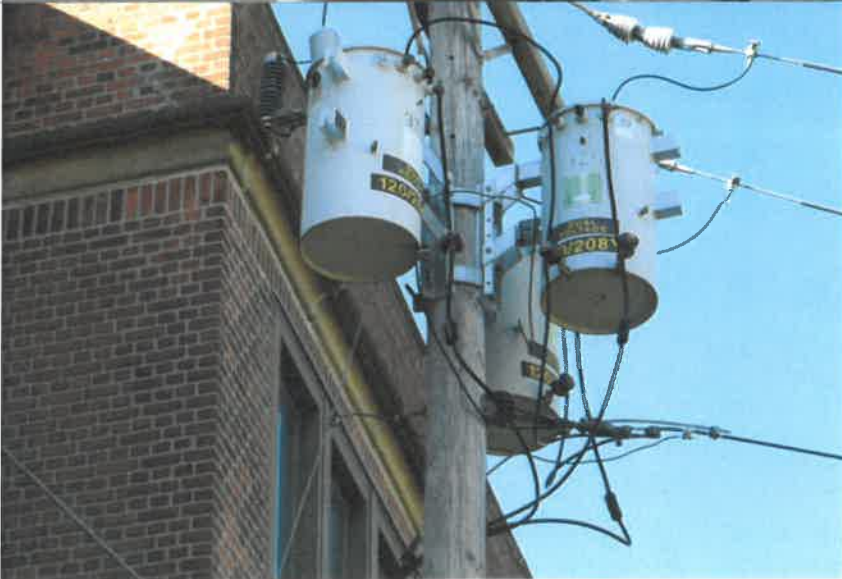
Photo # 60

120/208v pole-mounted step-down transformer.

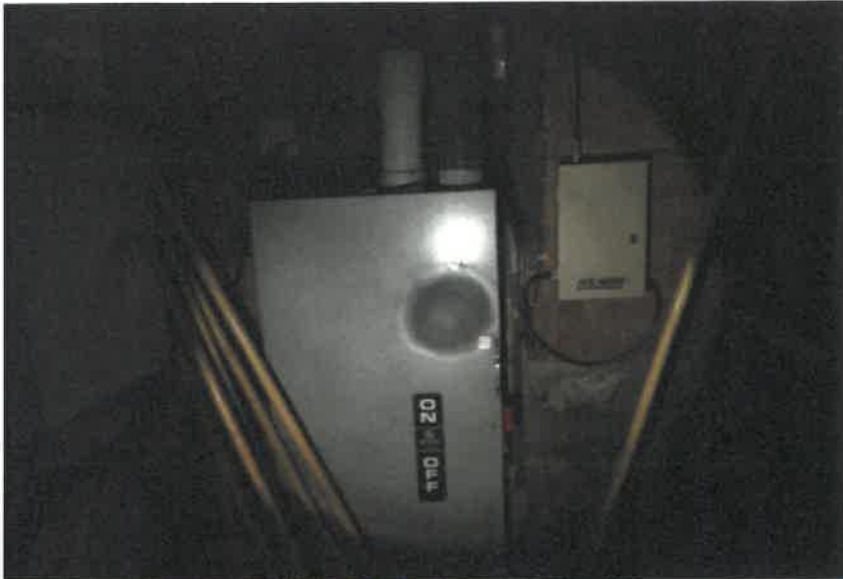
Photo # 61

400 Amp single-phase electrical main switch.

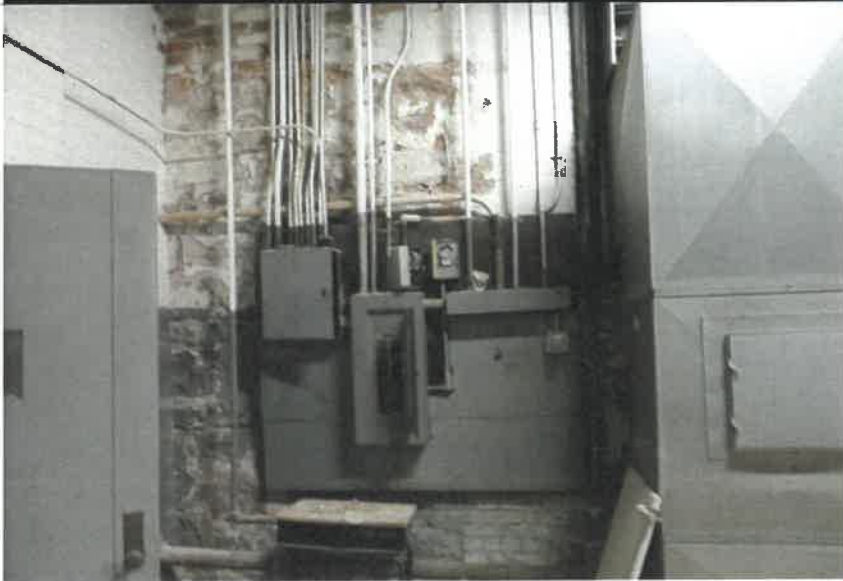
Photo # 62

Sub-panels in boiler room.

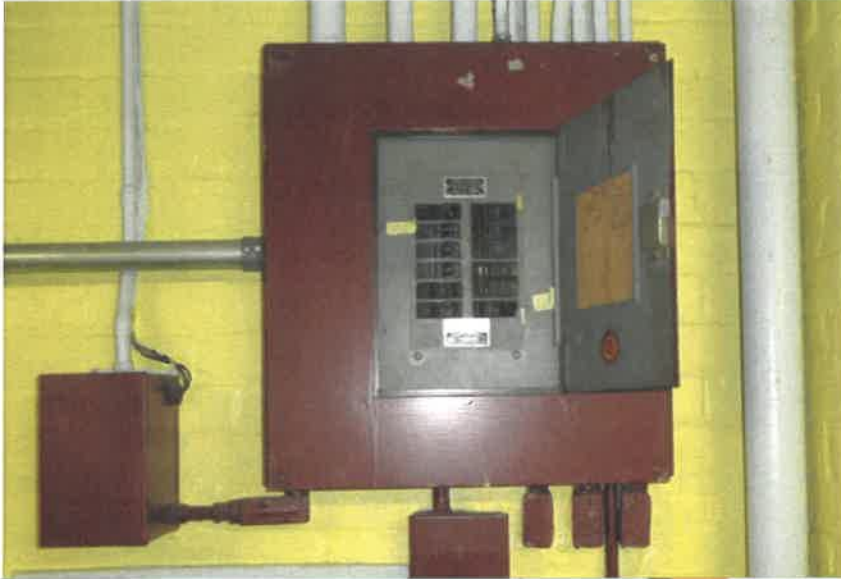
Photo # 64

Sub-panel in
basement hallway.

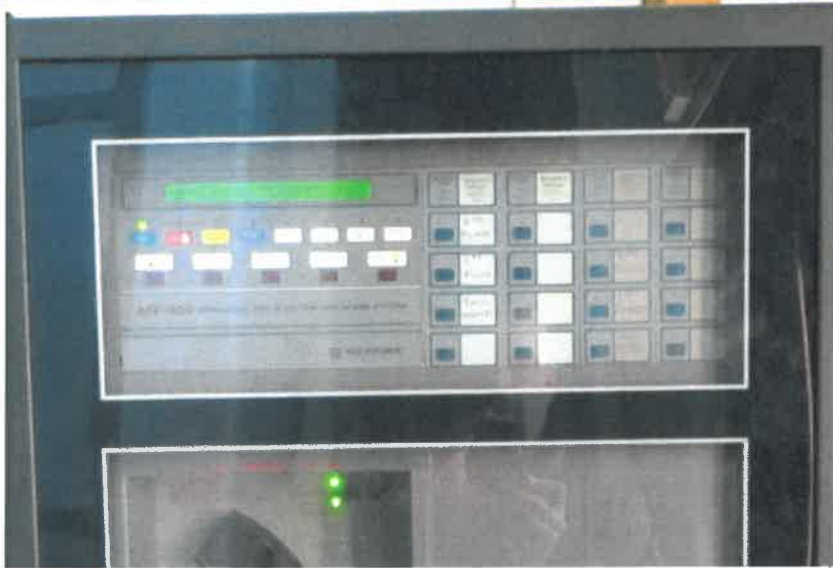
Photo # 66

The building has a central fire alarm panel (Honeywell Notifier AFP-300) provided by FireTech Engineered Systems located in the administration office and an annunciator panel at the Southeast (Grand Avenue) entrance (see photo 66). Audible annunciators, strobe lights, and pull-stations appear in good condition. No testing or maintenance records were available.

Central fire alarm
panel.

1. Fire and security alarm systems should be tested and repaired as needed
2. Redo exterior sealant at all doors and windows to help determine source of leaks

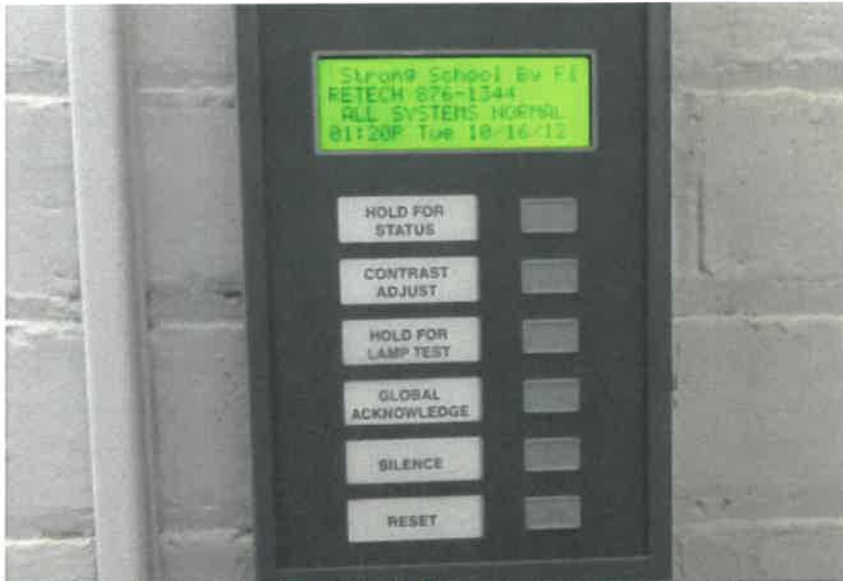
Photo # 67

Annunciator panel
at Grand Avenue
entrance.

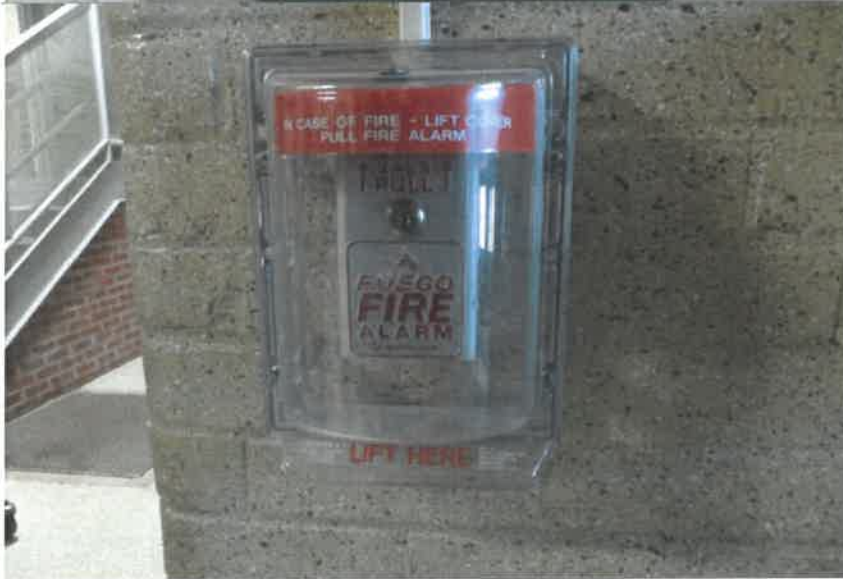
Photo # 68

Fire alarm pull-
station -- typical.

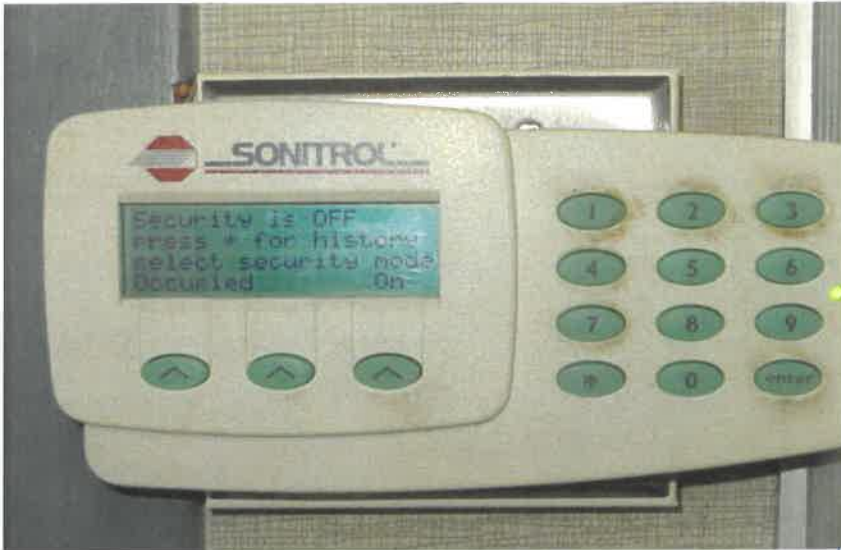
Photo # 69

The building has a security system but no information was available. A Sonitrol panel appeared to be in working order (see photo 69).

Security system panel.

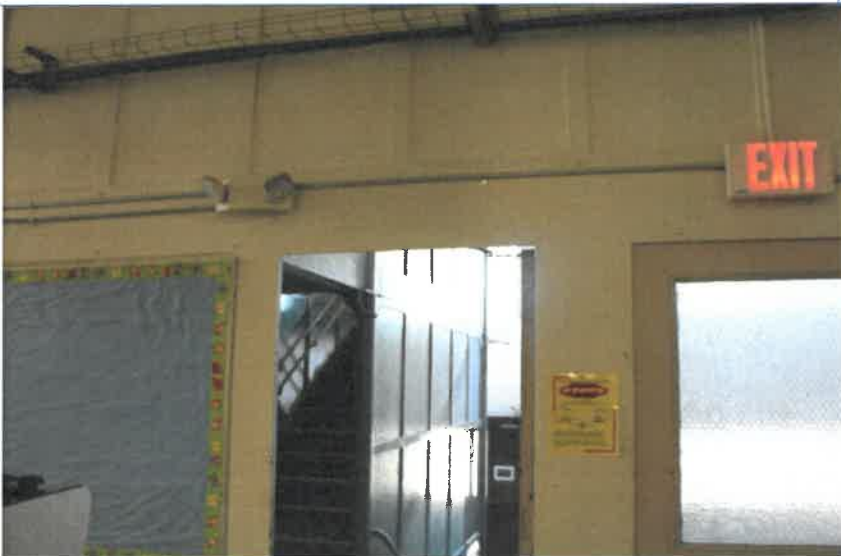
Photo # 70

Emergency lighting is provided by individual wall-pack units. Emergency lighting and illuminated exit signs tested were operational (see photo 70). There are no back-up power facilities.

Emergency lighting wall packs and illuminated exits signs – typical.

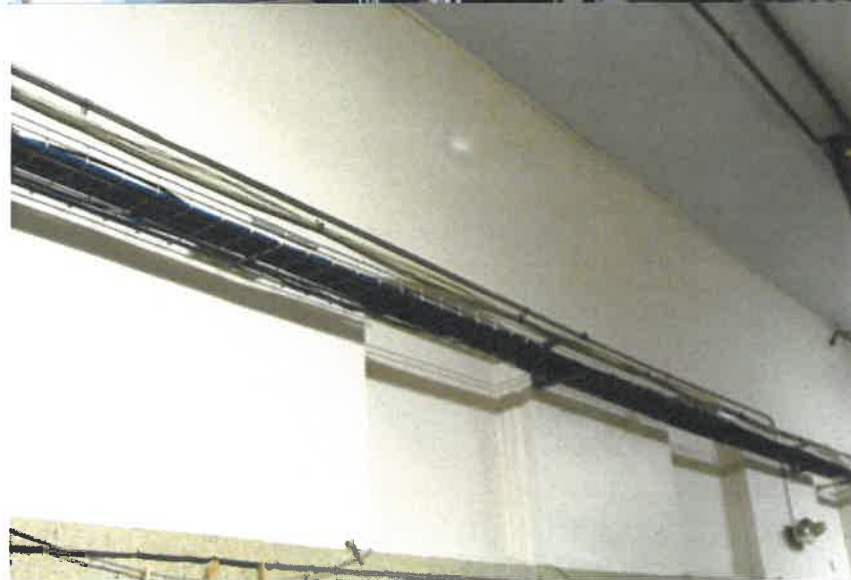
Photo # 72

Cat 5 wiring in
cable tray installed
along hallways.
